Q Geology and Soils Impact Assessment

Western Renewables Link EES Technical Report EES Technical Report Q

IS311800-EES-CG-RPT-0001 | 1.0 17 June 2025

AusNet Transmission Group Pty Ltd

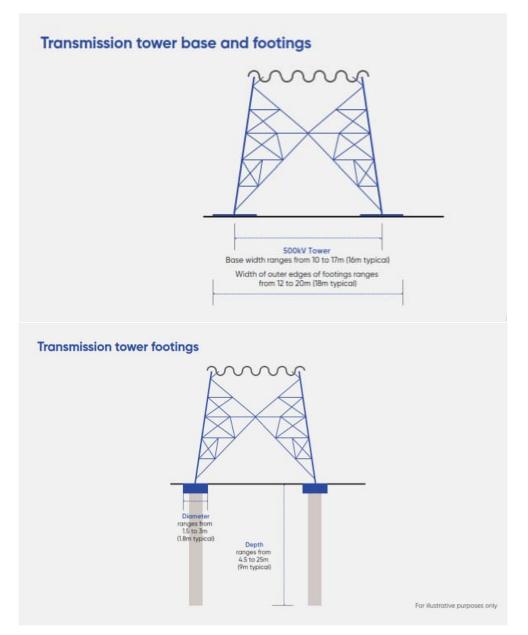
Figure 3.4: Proposed transmission line tower base and footings dimensions (Source: AusNet, 2025)

The below ground work at each tower will take approximately four weeks, with about nine days per footing for excavation, installation of reinforcement and concrete pouring. The overall construction duration could extend to approximately seven weeks from mobilisation to de-mobilisation. Construction may occur at multiple transmission towers at the same time.

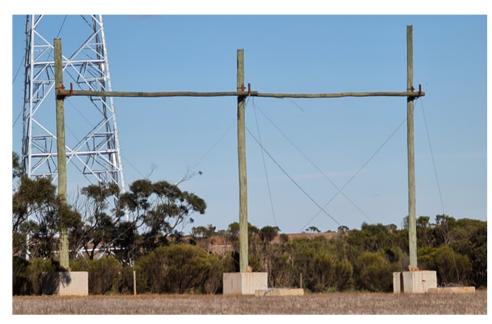
There are two common ways of installing hurdles. The first method involves drilling and inserting at least two timber poles into the ground using an auger drill and crane and installing a crossbeam between the poles, which acts as a barrier to prevent conductors falling or contacting the ground. Where drilling cannot be undertaken due to environmental or cultural heritage constraints or where it is difficult to implement, purpose-built prefabricated concrete stay blocks will be placed on the ground and timber poles inserted into these blocks and cross-beams installed. These poles have stay wires installed that are tied back to additional concrete blocks to provide further support. Examples of these protective works are shown in Figure 3.6 below.

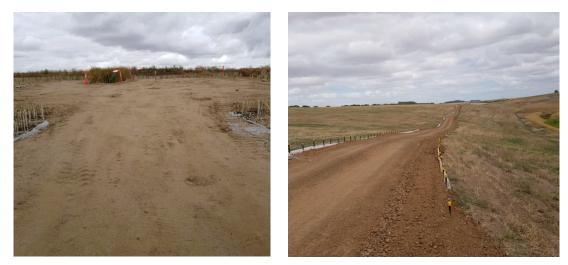
Figure 3.7: Examples of typical access tracks (Source: AusNet, 2024)

Temporary tracks will be reinstated to previous conditions, subject to the requirements of the landholder who may prefer to use the track for other purposes. Requests from landholders for permanent access tracks will be considered. An example of typical access tracks is shown in Figure 3.7 below.

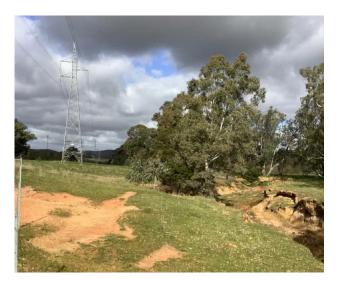
Figure 6.1: Creek incised into Shepparton Formation looking southeast along existing 220 kV from EG-CP05 (Source: Jacobs, 2022)

The section from Bulgana to Lexton lies within the Western Uplands geomorphic province. The landscape is characterised by undulating hills and ridges separated by valleys and incised creeks. The topography varies from moderate to steep slopes on valley sides to gently undulating areas valley bottoms. Examples of typical landscapes observed in this section are shown below in Figure 6.1 and Figure 6.2.

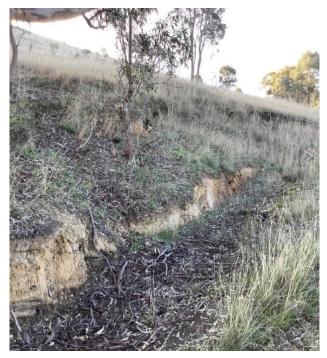
Figure 6.3: Erosion of residual soils (Pyrenees Formation) adjacent to a road on a steep hillside close to the Proposed Route, observed at EG-CP07 (Source: Jacobs, 2022)

Site observations undertaken during the site walkover generally indicated consistency with the susceptibility mapping. Areas of observed erosion generally appeared to be due to the disturbance or removal of topsoil for farming and road construction (see Figure 6.3 and Figure 6.4). Table 6.3 indicates a low susceptibility to gully erosion for granite derived colluvium, however particle size testing undertaken on a sample obtained from the colluvium shown in Figure 6.4 indicates the material has a high percentage of sand with some silt, and, therefore, likely to be susceptible to erosion by water and wind (refer to Appendix B and Appendix C for details).

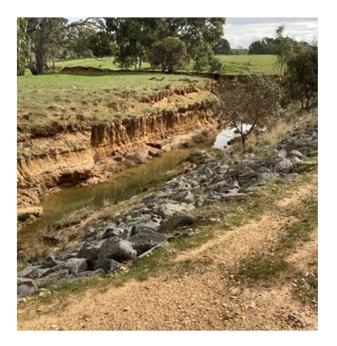
Figure 6.7: Slumping of gully sides observed at site walkover checkpoint EG-CP04, with active stabilisation measures (rock beaching) in the foreground (Source: Jacobs, 2022)

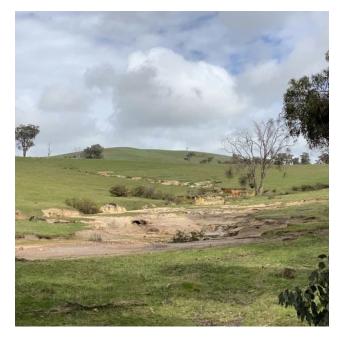
Figure 6.9: Active gullying observed on a slope west of site walkover checkpoint EG-CP15 (Source: Jacobs, 2022)

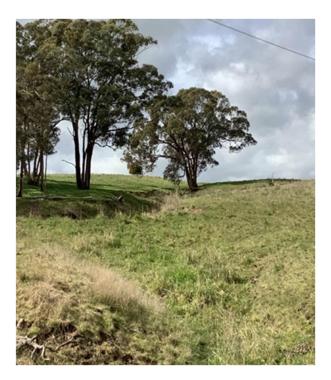
Figure 6.11: Recent gully erosion observed at site walkover checkpoint EG-CP17 (Source: Jacobs, 2022)

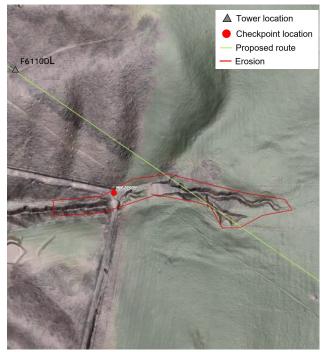
Figure 6.12: Mapped area of gully erosion near site walkover checkpoint EG-CP17 shown on LiDAR DEM (Source: Jacobs, 2024)

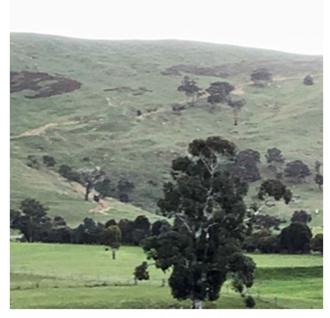
Figure 6.13: Hummocky slope terrain suggesting past land instability, looking west from site walkover checkpoint EG-CP05 (Source: Jacobs, 2022).

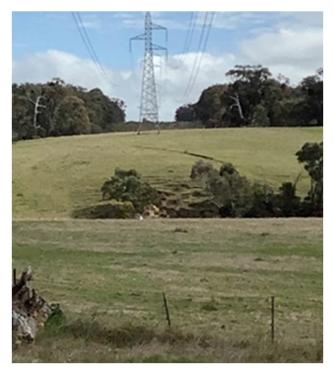
Figure 6.15: Possible soil creep on hillslope west of site walkover checkpoint EG-CP16 (Source: Jacobs, 2022).

Soil creep was observed and mapped to the west of site walkover checkpoint EG-CP16, as shown in Figure 6.15 and Figure 6.16. Soil creep was observed in two locations, on the hill slope and at the bank of the creek.

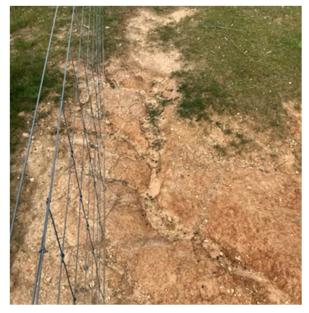
Figure 6.19: Erosion and exposed soils observed at EG-CP04 (Source: Jacobs, 2022)

Salt scalding, which indicates elevated soil salinity was observed at EG-CP04 and EG-CP15 are shown below in Figure 6.17 and Figure 6.18. These areas typically display exposed soils with little to no vegetation growth and a white crust on the surface.

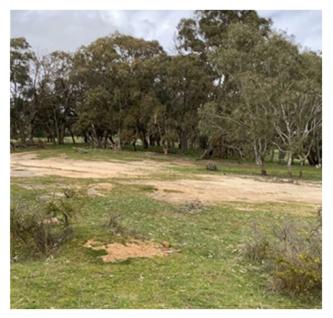
Figure 6.20: White crust observed on exposed soils at EG-CP15 (Source: Jacobs, 2022)

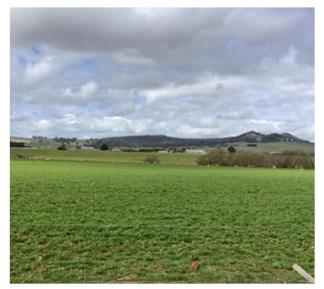
Figure 6.21: Granite hills surrounded by flat plains of the Newer Volcanic Group basalt and gently sloping deposits of colluvium at the base of hills, looking west from EMO-CP03 (Source: Jacobs, 2022)

The section from Lexton to Ballan lies within the Western Uplands geomorphic province. Landforms are characterised by gently undulating hills with isolated steep hills associated with local volcanic eruption points. The topography varies from flat plains to steep slopes on valley sides and eruption point slopes to gently undulating areas in broad valleys. Examples of typical landscapes observed in this section are shown below in Figure 6.21 and Figure 6.22.

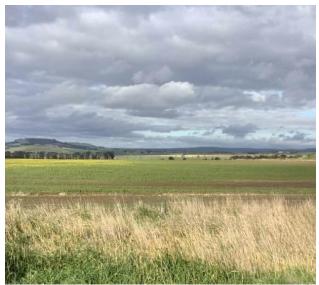
Figure 6.22: Eruption point (Scoria cone) surrounded by flat plains of the Newer Volcanic Group basalt, looking north from EMO-CP08 (Source: Jacobs, 2022)

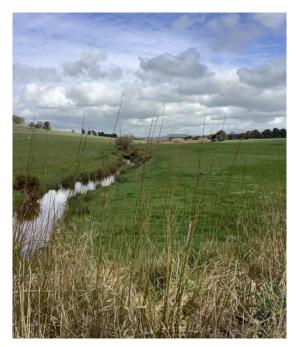
Figure 6.23: EMO associated with creek, no active erosion, taken at EMO-CP02 (Source: Jacobs, 2022)

are generally associated with surface watercourses and areas mapped as the geological unit Nes (scoria deposits), which are positive relief features that represent eruption centre locations. An example of an area subject to the overlay is associated with a watercourse near EMO-CPO2 is shown in Figure 6.23, whilst an example of an EMO area associated with a scoria cone near EMO-CPO8 is shown in Figure 6.24. No evidence of active erosion was observed at either checkpoint location. The extents of the EMO within the Lexton to Ballan section are illustrated in Figure A.7.2 in Appendix A.

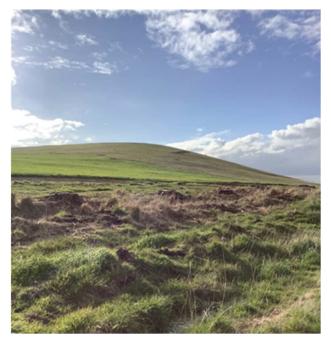
Figure 6.24: EMO area associated with eruption point (Scoria cone, surrounded by flat plains of the Newer Volcanic Group basalt), looking north from EMO-CP08 (Source: Jacobs, 2022)

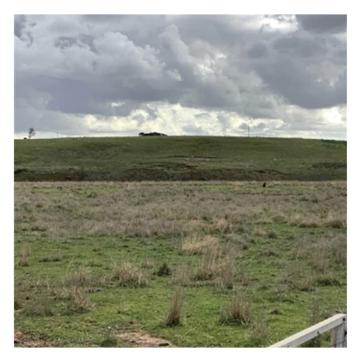
Figure 6.27: Progressive creep on sides of creek valley, looking east from EMO-CP07 (Source: Jacobs, 2022)

Only minor land instability was observed within the Lexton to Ballan section and was generally observed on creek banks where creeks have incised into the underlying basalt rock. An example includes minor soil creep which was observed on the sides of a creek valley at EMO-CP07 which is likely due to natural erosion of the creek. Site observations and mapping from EMO-CP07 can be seen in Figure 6.27 and Figure 6.28. The Lexton to Ballan section is mapped as having a low to very low landslip susceptibility as described in Table 6.10 and shown on Figure A.5.2 in Appendix A. This susceptibility classification is consistent with observations undertaken on the site walkover.

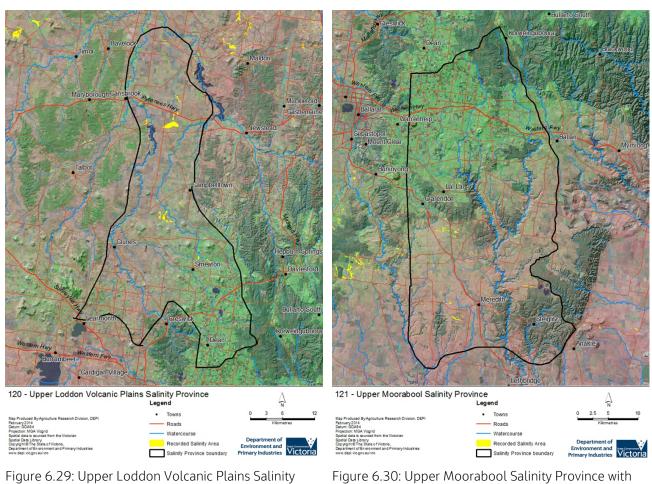
Figure 6.29: Upper Loddon Volcanic Plains Salinity Province with mapped Soil Salinity Areas shown in yellow (Source: DJSIR (formerly DEPI), 2014)

Soil salinity testing was conducted at EMO-CP09 on sandy silt of the Newer Volcanic Group residual soil. This test recorded ECe of 281 μ S/cm, which indicates that the soil is non-saline (Agriculture Victoria, 2020c). This test constitutes a very small sample size and may not be representative of the broader study area. The results of soil salinity testing conducted in the Lexton to Ballan study area section are summarised in Appendix B, with laboratory test certificates shown in Appendix C.

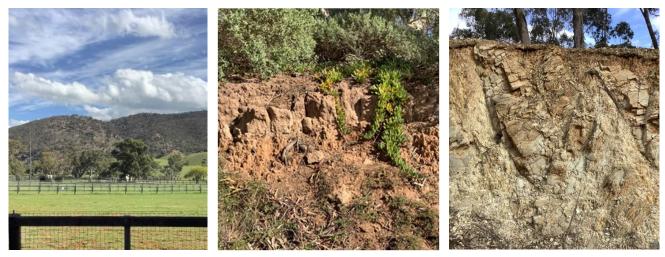
Figure 6.31: Castlemaine Group ridgeline, with alluvial flats in foreground associated with Lerderderg River. Rowsley faut line at base of slope. Looking west from EG-CP20 (Source: Jacobs, 2022)

The section from Ballan to Melton West is characterised by undulating hills and ridgelines in places combined with broad low-lying, flat areas. The topography varies from moderate to steep slopes in hilly areas to gently undulating to flat areas in broad valleys and plains. Examples of typical landscapes observed in this section are shown below in Figure 6.31, Figure 6.32 and Figure 6.33.

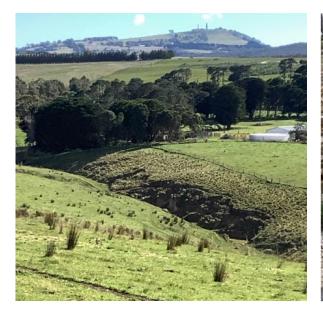
Figure 6.37: Natural erosion of creek causing instability of creek slopes at EG-CP18 (Source: Jacobs, 2022)

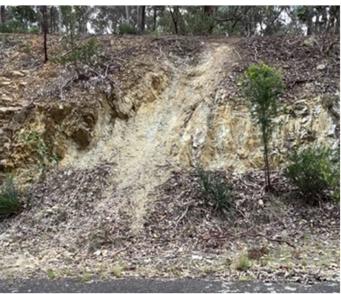
Figure 6.38: Localised slump failure in cut slope in the Riddell Sandstone observed near EG-CP23 (Source: Jacobs, 2022)

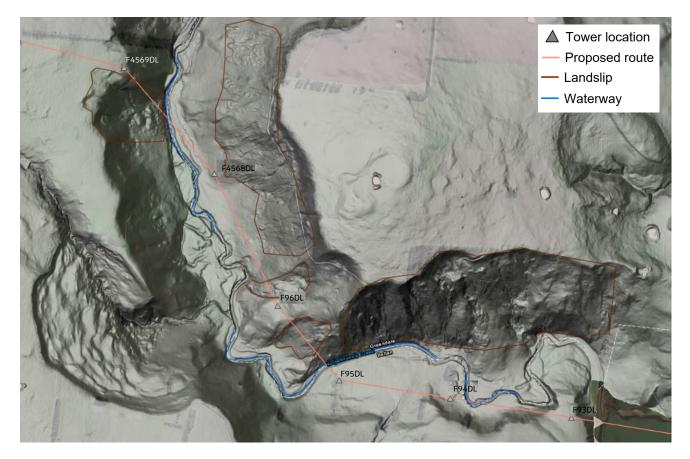
Figure 6.39: Mapped areas of earth flow and rotational land slip failures associated with volcanic eruption point near Pykes Creek Reservoir north of Ballan with LiDAR DEM (Source: Jacobs, 2024)

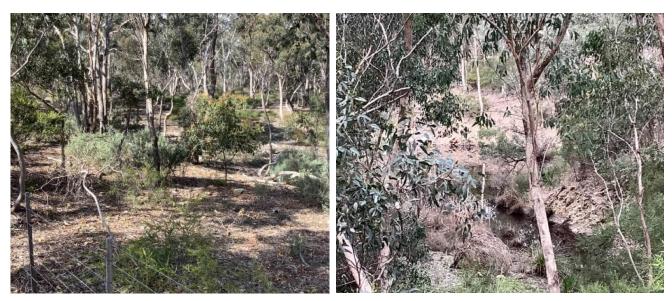
Figure 6.42: Historical gully erosion in heavily vegetated area near EG-CP22 (Source: Jacobs, 2022)

Figure 6.43: Natural erosion of Creek in Riddell Sandstone observed near EG-CP23 (Source: Jacobs, 2022)

vegetated areas was observed within the Castlemaine Group near EG-CP22 as shown below in Figure 6.42. Natural stream bank erosion was observed in the Riddell Sandstone near EG-CP23 as shown in Figure 6.43.

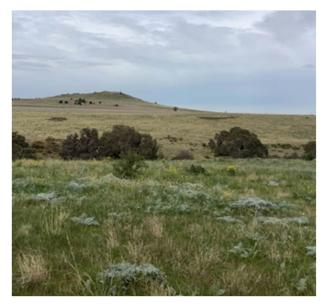
Figure 6.44: Kororoit Creek incising the Newer Volcanic Group basalt with Mount Kororoit eruption point in the background looking southeast from O-CP02 (Source: Jacobs, 2022).

The section from Melton West to Sydenham is characterised by flat plains with low-lying areas associated with watercourses and drainage lines. The topography varies from flat to gently undulating with a steep valley associated with the Kororoit Creek and isolated steep hills associated with eruption points (e.g., Mount Kororoit). Examples of typical landscapes observed in this section are shown below in Figure 6.44 and Figure 6.45.

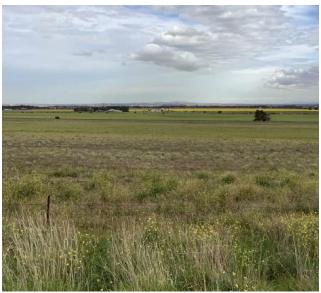
Figure 6.45: Newer Volcanic Group basalt plains looking south from GSF-CP02 (Source: Jacobs, 2022).

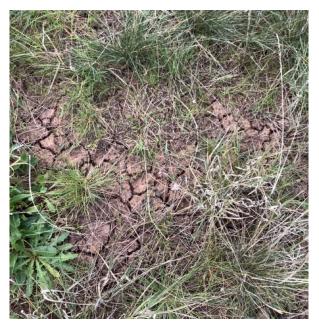
Signs of reactivity in the Newer Volcanic Group residual soils was observed, as shown by the example of shrinkage cracking seen in clay soils near O-CPO2 (refer to Figure 6.49). The shrink swell cracking of exposed

soils is due to contraction of the clay as a result of reduction in moisture content below soil shrinkage limit. Atterberg testing was undertaken on a high plasticity clay sample from O-CP02. The plasticity index of the residual clay sample at O-CP02 recorded a value of 41% (LL=61%), which indicates the soils in this area display high to very high soil reactivity (Holtz and Gibbs, 1956 and Seed et al. 1962).

Figure 6.49: Shrink swell cracking observed in Newer Volcanics residual clay soil at O-CP02 (Source: Jacobs, 2022)

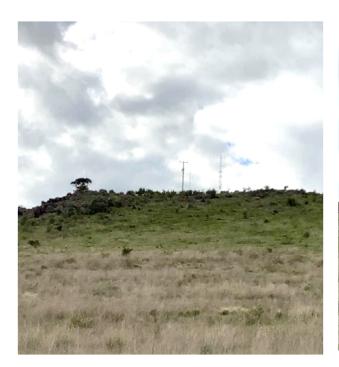
Figure 6.50: Mt Kororoit eruption point with phone and radio towers observed looking north from GSF-CP02 (Source: Jacobs, 2022)

Mount Kororoit exhibits large areas of rock outcropping on the summit and low slopes. These examples of basalt rock are a major reason as to why the eruption point has been designated as a significant feature. An existing phone and radio tower supplying small power line is present at the top of the feature. Observations of the Mount Kororoit recorded at GSF-CP02, which show examples of the eruption point and basalt rock outcrops can be seen in Figure 6.50 and Figure 6.51 respectively.

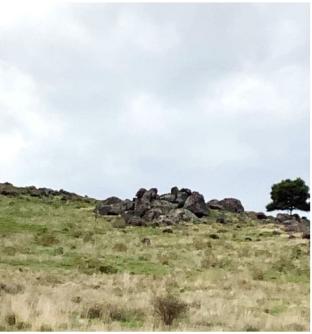
Figure 6.51: Newer Volcanic Group basalt outcrop on side of slope at Mt Kororoit observed looking north from GSF-CP02 (Source: Jacobs, 2022)

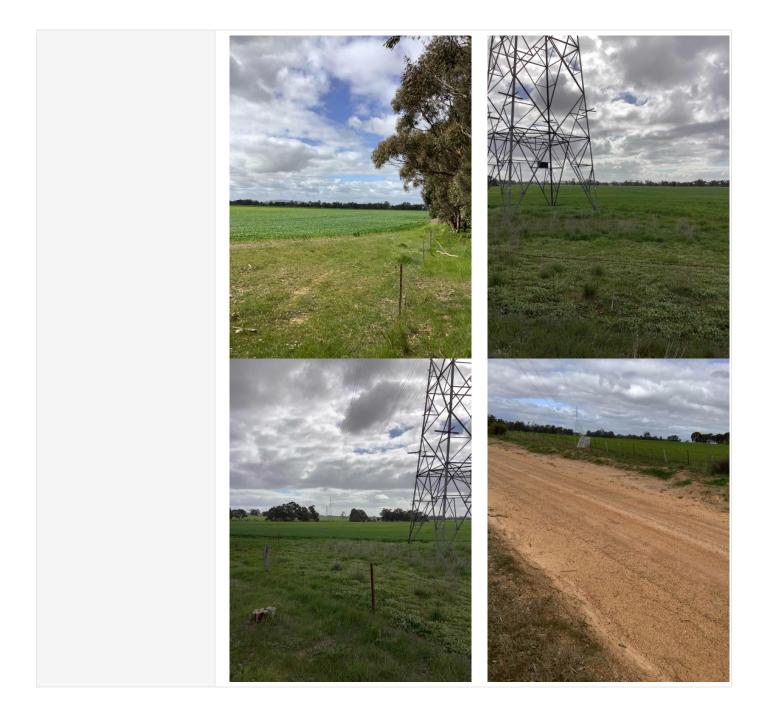
Notes on Landslide Susceptibility			
Notes on Geological Significant Features			
General Ground Conditions Comments	Tower location in area of farmland. Shepparton Formation and White Hills Gravel geology.		
Notes on Topography	Flat farmland, low lying gentle undulations.		
Other Observations	Soil sample 1, Sandy SILT: low plasticity, pale brown, sand fine grained, trace gravel (Shepparton Formation, taken near creek). Soil sample 2, Clayey Silty SAND: fine grained, red brown, medium plasticity clay (Shepparton Formation). Sample taken near alignment, no obvious signs of salinity impacts, soil supporting crop growth.		
Photos	<image/>

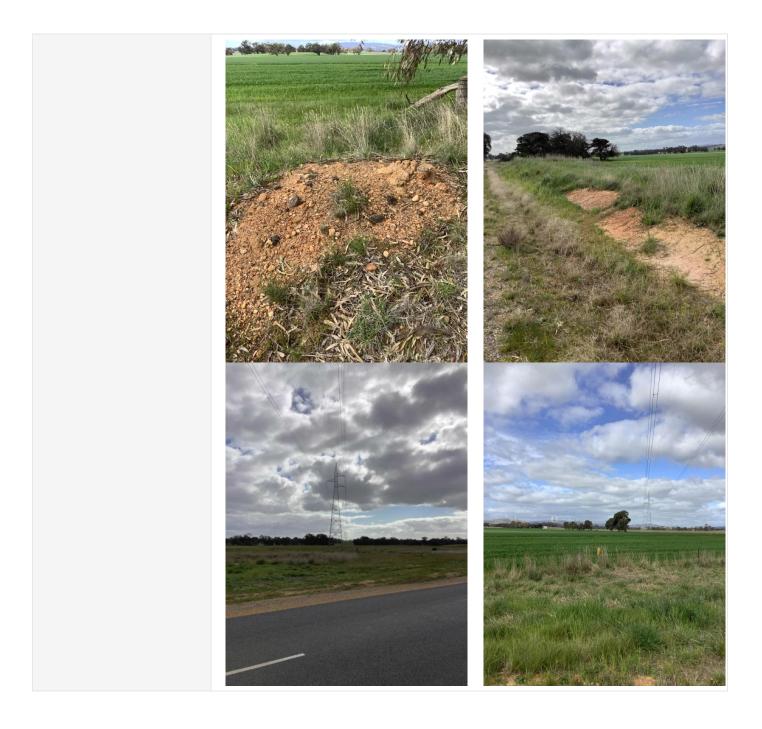
Notes on Geological Significant Features			
General Ground Conditions Comments	Possible soft soils in alluvium, geology is Shepparton Formation with areas of alluvium to west and Warrack Formation to east.		
Notes on Topography	Flat to slightly undulating, low lying areas.		
Other Observations	Soil sample 3 taken, Clayey Silty SAND: fine grained, red brown, medium plasticity clay, trace gravel (Shepparton Formation, no signs of erosion or salinity impacts).		
Photos	<image/>

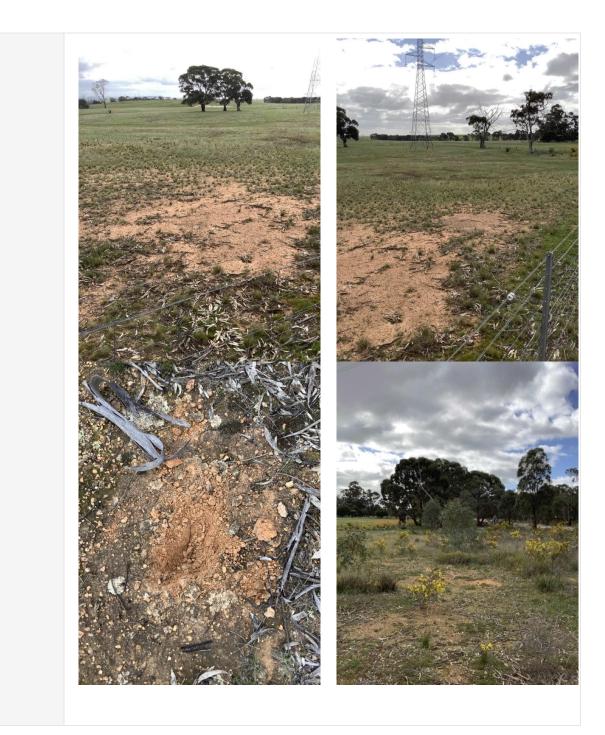
Notes on Geological Significant Features			
General Ground Conditions Comments	Area is mostly White Hills Gravel with Shepparton Formation to south and Warrack Formation to north.		
Notes on Topography	Moderately undulating.		
Other Observations	Soil sample 4, Gravelly SAND: fine to coarse, red brown, with trace clay (White Hills Gravel).		
Photos	<image/>

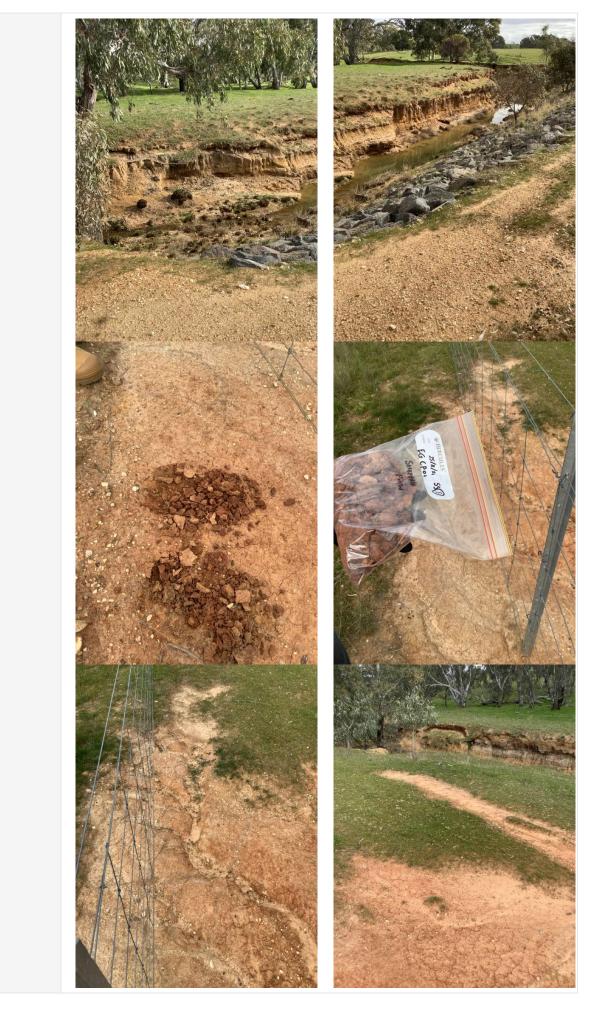
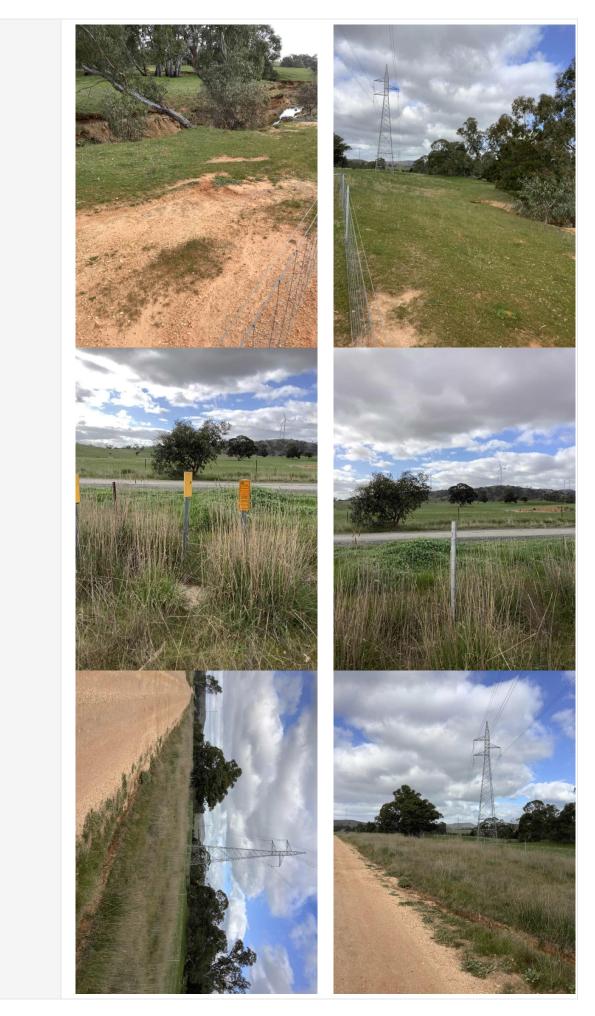
Notes on Geological Significant Features		
General Ground Conditions Comments	Localised failures observed in creek, geology is Shepparton Formation in low lying valley, Warrack Formation in hills, natural material shows potential for erosion when exposed to runoff.	
Notes on Topography	Undulating to hilly topography.	
Other Observations	Soil sample 5, SILT: low plasticity, red brown, with fine to coarse quartz gravel, rounded, with clay (Shepparton Formation). Check for geotechnical reports for Crowlands WF.	
Photos	<image/>

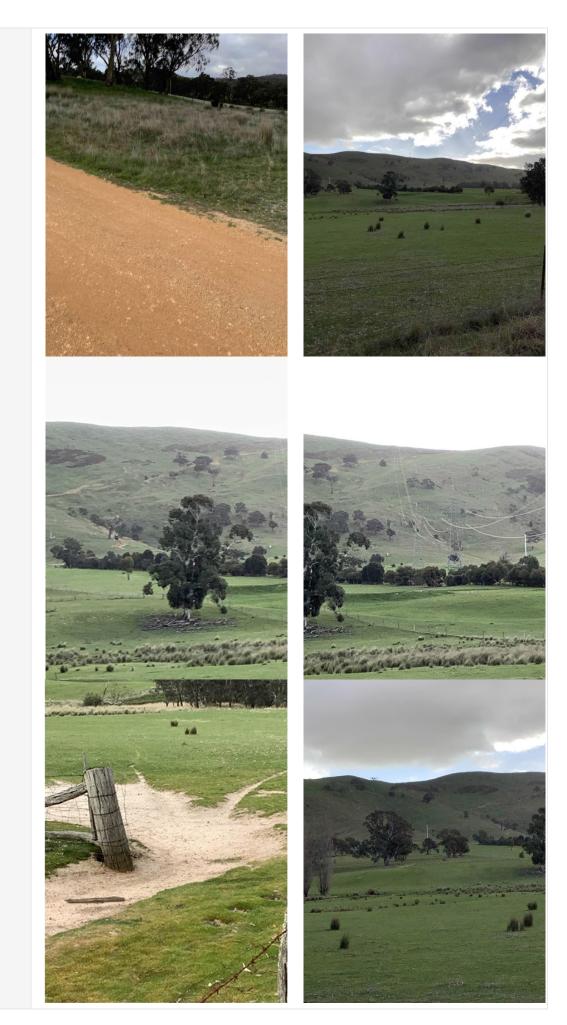
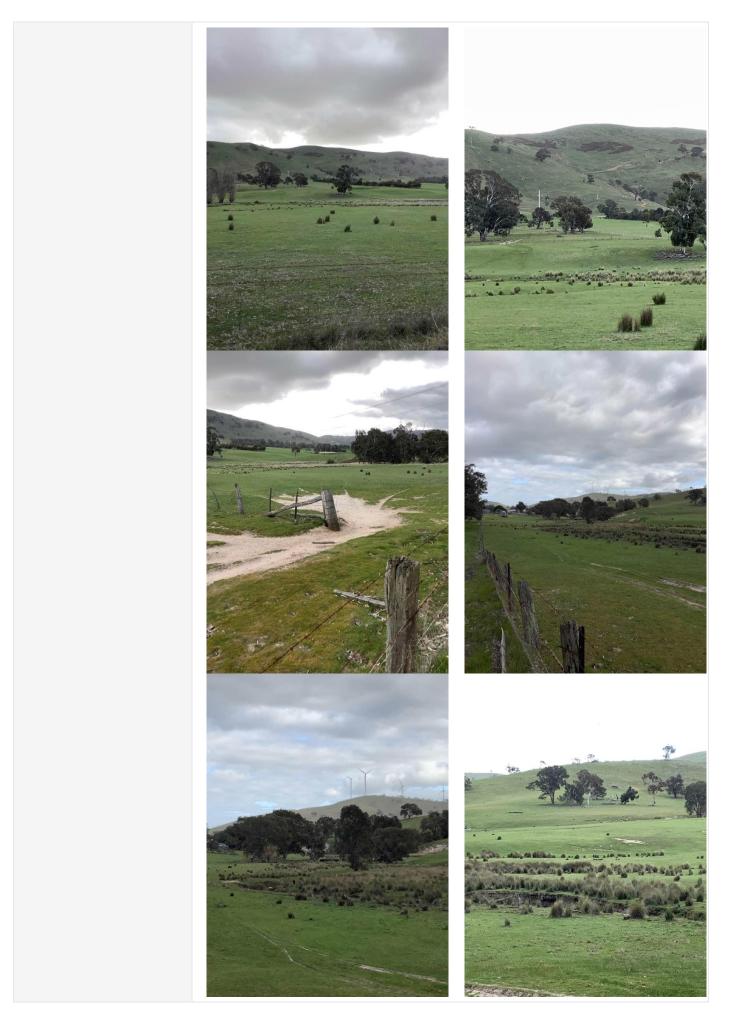
Notes on Geological Significant Features	High strain fault area associated with Lansborough fault to west at top of hill.		
General Ground Conditions Comments	Shepparton Formation in valley and Warrack Formation and Pyrenees Formation to east.		
Notes on Topography	Very steep hills and low-lying alluvium areas.		
Other Observations	Soil sample 6, SILT: low plasticity, red brown, with fine to coarse quartz gravel, rounded, with clay (Shepparton formation). Possibly some soil creep on valley sides.		
Photos	<image/>

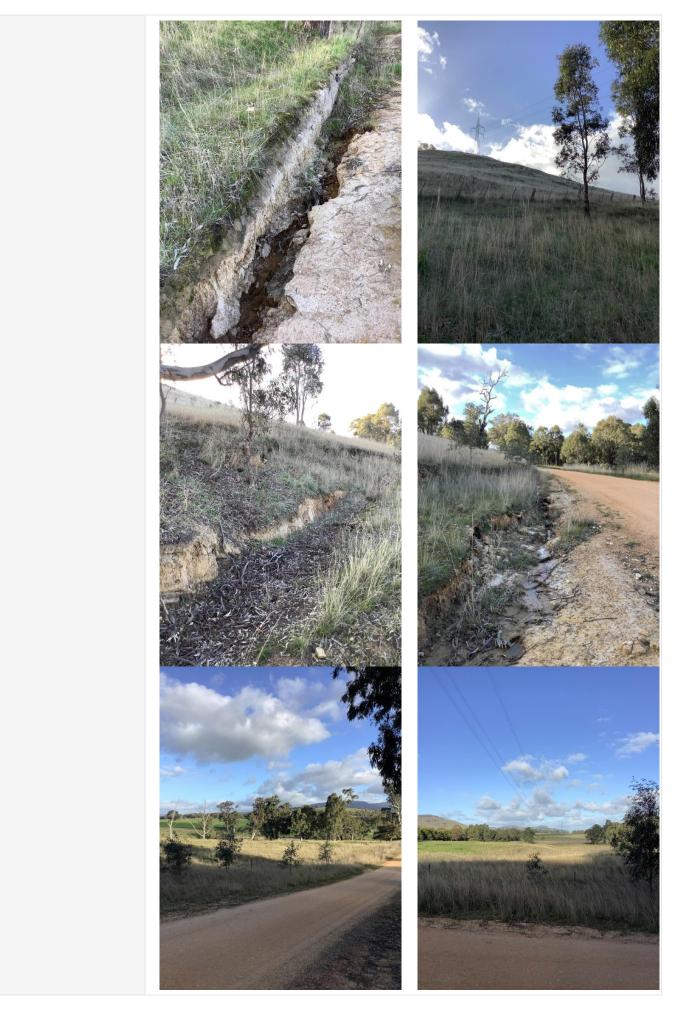
Notes on Geological Significant Features			
General Ground Conditions Comments	Pyrenees Formation hills to north and alluvium associated with Wimmera River to the south, inferred rock depth quite shallow on slopes, rock boulders on slopes.		
Notes on Topography	Steep slopes and low-lying flat alluvium.		
Other Observations	Soil sample 7, SILT: low plasticity, light brown, with trace clay (Pyrenees Formation).		
Photos	<image/>

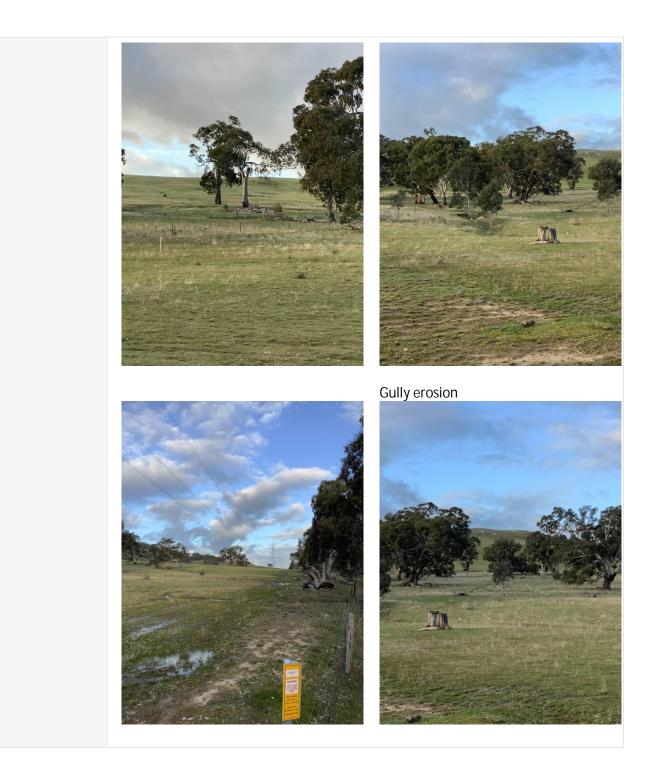
Notes on Geological Significant Features			
General Ground Conditions Comments	Glenlogie Granodiorite and granite derived colluvium at base of slopes.		
Notes on Topography	Hilly topography.		
Other Observations	Sample 8, Sandy CLAY: medium plasticity, brown, with gravels (Glenlogie Granodiorite).		
Photos

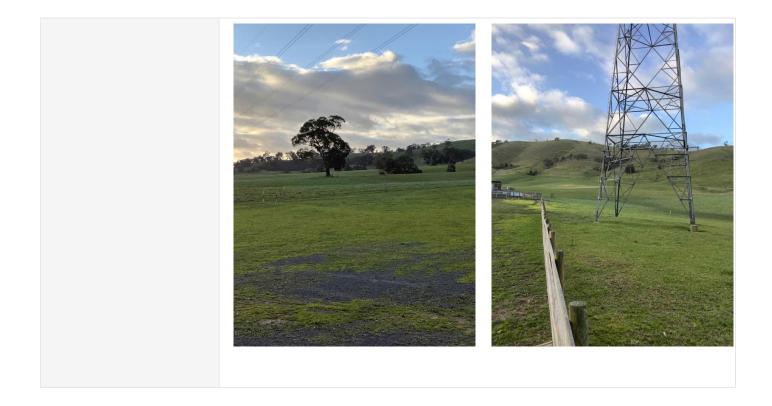
Notes on Geological Significant Features	Granite exposure to north of alignment.		
General Ground Conditions Comments	Transmission line passes through area of granite derived colluvium at base of slope.		
Notes on Topography	Gentle slopes in colluvium and steep slopes to north in granite hills.		
Other Observations	Soil sample 9, SAND: fine to coarse, brown, with fine gravel, trace fines (granite derived colluvium).		
Photos	<image/>

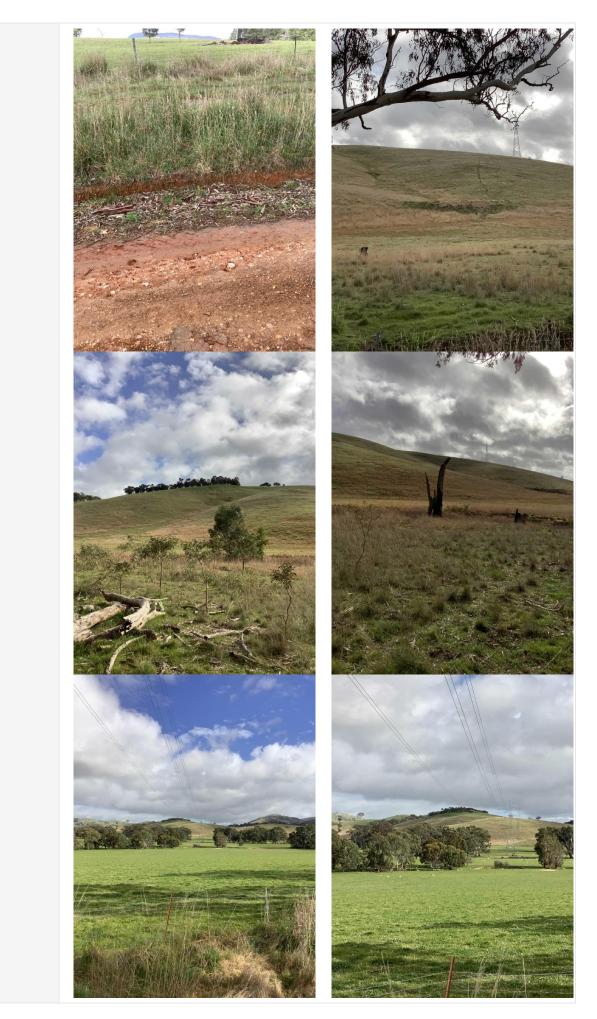
Notes on Geological Significant Features			
General Ground Conditions Comments	Pyrenees Formation in the hills, Shepparton Formation in low lying creek area to the east, soil creep on steeper part of hills.		
Notes on Topography	Hilly topography.		
Other Observations	Soil sample 10, CLAY: Medium plasticity, red brown, with sand/gravels (Pyrenees Formation).		
Photos	<image/>

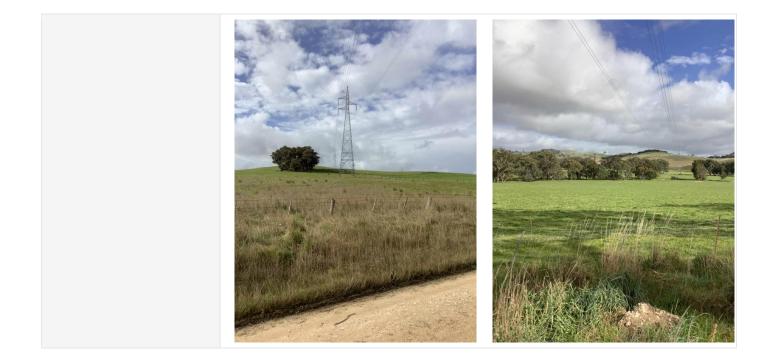
Checkpoint ID		EG-CP12
Precinct		Western Precinct
Address		Amphitheatre Rd
Coordinates		Property of the second
Are there signs of erosion or gullying or areas susceptible to erosion and gullying? (Yes/No)		Yes
Are there signs of erosion management? (Yes/No)		No
Are there signs of landslides or areas of landslide susceptibility visible? (Yes/No)		Yes
Are there any geological significant features? (Yes/No)		No
Notes on Erosion and Gullying	Possibly erosion on hills creeks.	but since stabilised, some evidence of natural erosion in
Notes on Erosion Management		
Notes on Landslide Susceptibility Steeps may be prone to		land slips or instability if disturbed.

Notes on Geological Significant Features			
General Ground Conditions Comments	Beaufort Formation in hills to west, Shepparton Formation and recent alluvium in valley. Evidence of rock outcropping on hills.		
Notes on Topography	Very hilly in Beaufort Formation, flat in low lying Shepparton Formation.		
Other Observations	Current land use, farmland and pasture.		
Photos

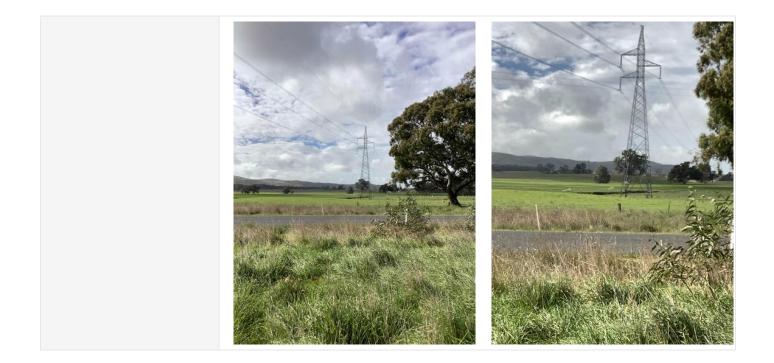
Checkpoint ID		EG-CP13	
Precinct		Western Precinct	
Address		Lexton Ararat Rd	
Coordinates		¹ ¹ 8 ¹ Rd ¹ e⊙ _A arat Rd	
Are there signs of erosion or gullying or areas susceptible to erosion and gullying? (Yes/No)		Yes	© Mapbox, © OpenStreetMap
Are there signs of erosion ma	anagement? (Yes/No)	No	
Are there signs of landslides or areas of landslide susceptibility visible? (Yes/No)		No	
Are there any geological significant features? (Yes/No)		No	
Notes on Erosion and Gullying	Minor erosion around w	ater courses.	
Notes on Erosion Management			
Notes on Landslide Susceptibility

Notes on Geological Significant Features			
General Ground Conditions Comments	Pyrenees Formation in hills, granite in valley, rock outcropping on hills, alignment passes through granite in valley.		
Notes on Topography	Alignment moderately undulating ground surrounded by steep hills.		
Other Observations	Soil sample 11, Silty SAND: fine to medium, red brown, low plasticity fines (Mount Lonarch Granite).		
Photos	<image/>

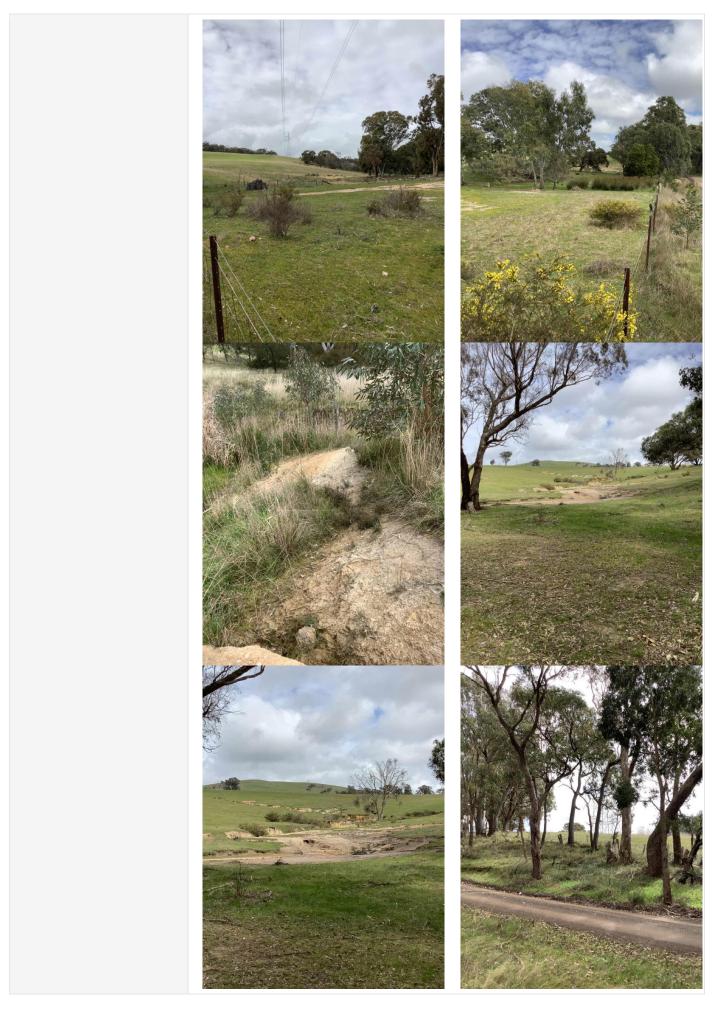
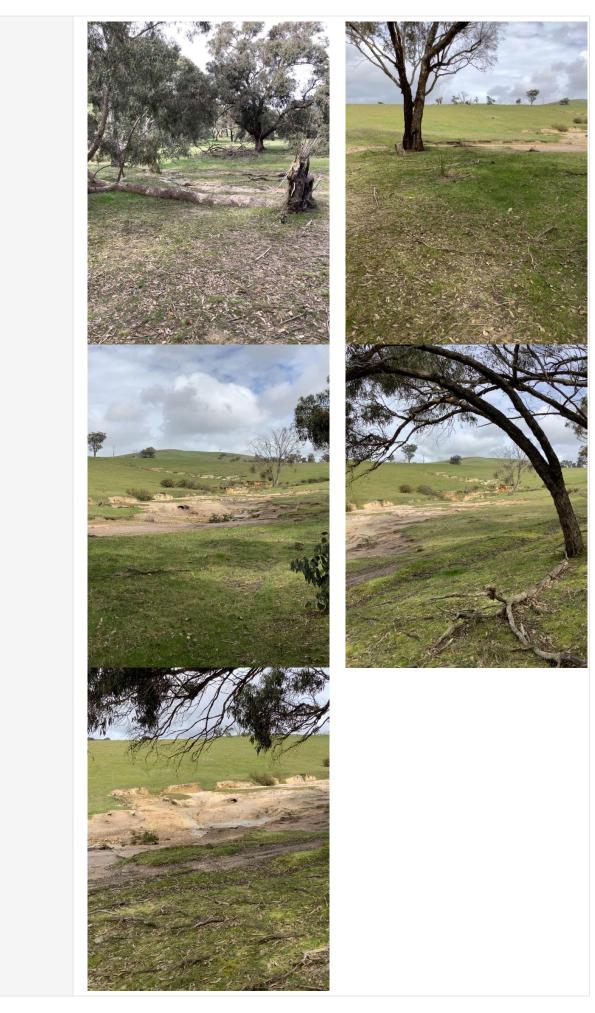
Notes on Landslide Susceptibility			
Notes on Geological Significant Features			
General Ground Conditions Comments	Pyrenees Formation with areas of White Hills Gravel in low lying areas, white crust observed on bare patches of soil.		
Notes on Topography	Moderately undulating.		
Other Observations	Soil sample 12, CLAY: medium plasticity, red brown (Pyrenees formation residual soil). Soil sample 13, Clayey SILT: low plasticity, brown, with gravels (residual soil, possible White Hills Gravel).		
Photos	<image/>

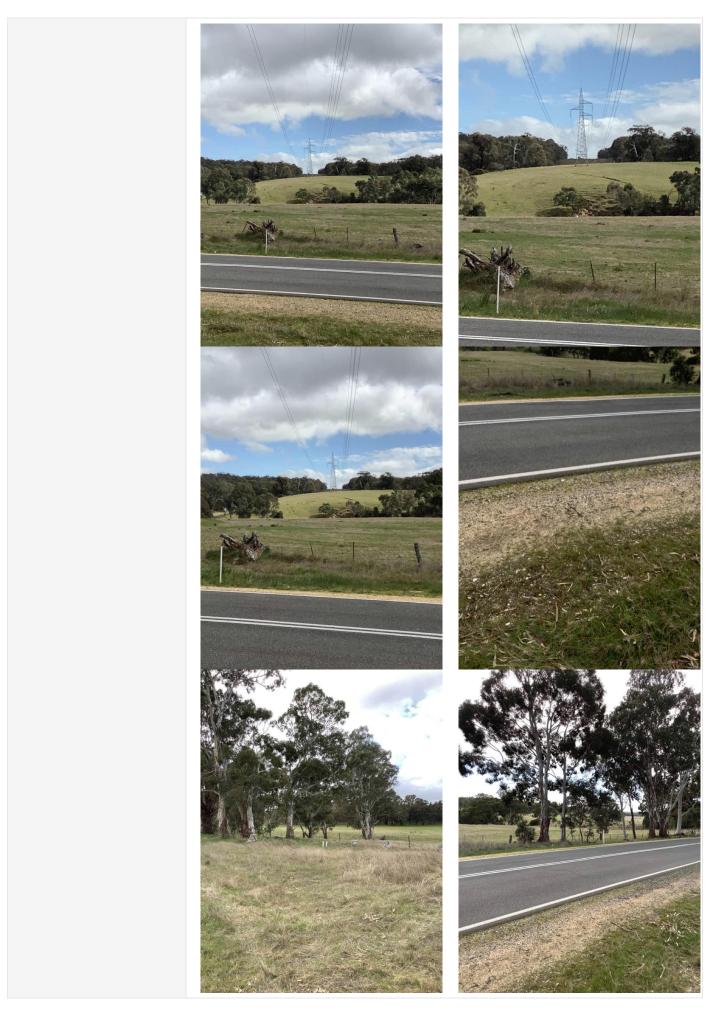
Notes on Geological Significant Features			
General Ground Conditions Comments	Alluvium in low lying areas and sedimentary units in hills.		
Notes on Topography	Moderately undulating to hilly.		
Other Observations			
Photos	<image/>

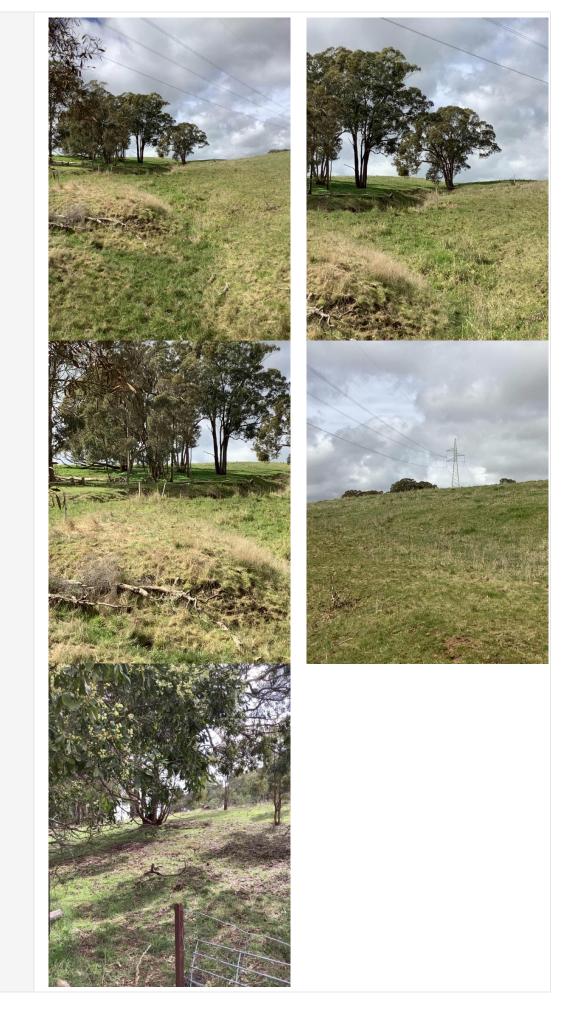
Notes on Geological Significant Features	
General Ground Conditions Comments	Geology is Pyrenees Formation, evidence of thin layer of colluvium overlying residual soil.
Notes on Topography	Hilly topography.
Other Observations	Soil sample 14, Clayey Silty SAND: fine to medium, light brown, with trace gravel (Pyrenees Formation).
Photos	<image/>

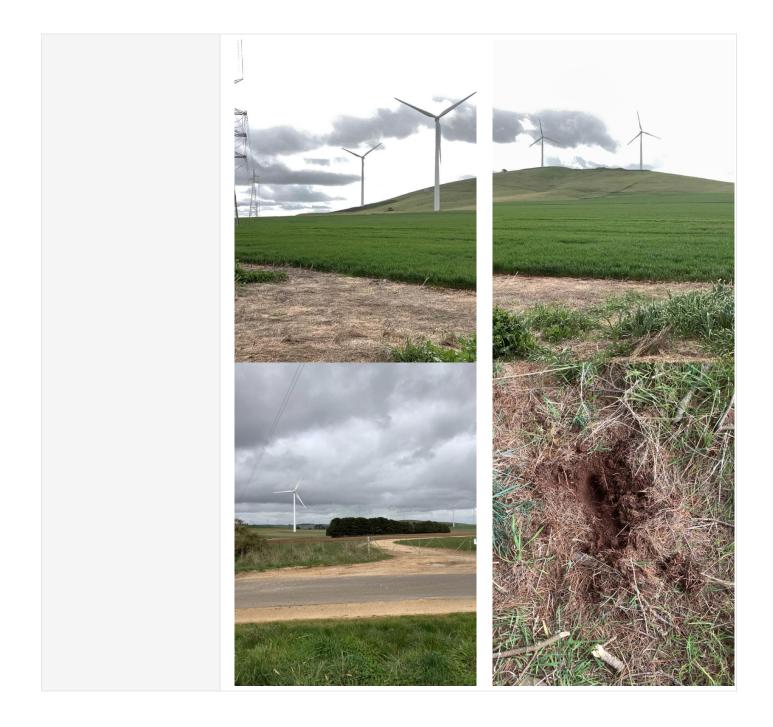
Notes on Geological Significant Features	Two volcanic eruption points to the north of the alignment.		
General Ground Conditions Comments	Newer Volcanics basalt and scoria cones associated with eruption points.		
Notes on Topography	Slightly undulating to flat in low lying areas with hills surrounding.		
Other Observations	Soil sample 15, Clayey SILT (Newer Volcanics residual soil). Site adjacent to Waubra WF and TS. Existing wind turbine foundation north of alignment appears to have benched backfill on side of slope. Land use for crops and grazing.		
Photos

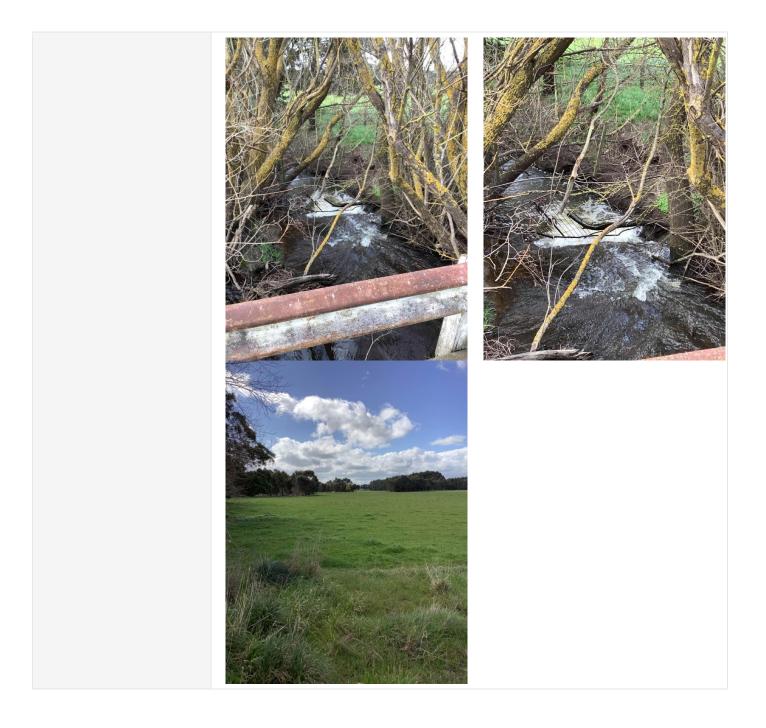
Notes on Landslide Susceptibility	
Notes on Geological Significant Features	
General Ground Conditions Comments	Alluvial flats within basalt plains surrounded by granite hills.
Notes on Topography	Flat topography around creek surrounded by hills.
Other Observations	
Photos	<image/>

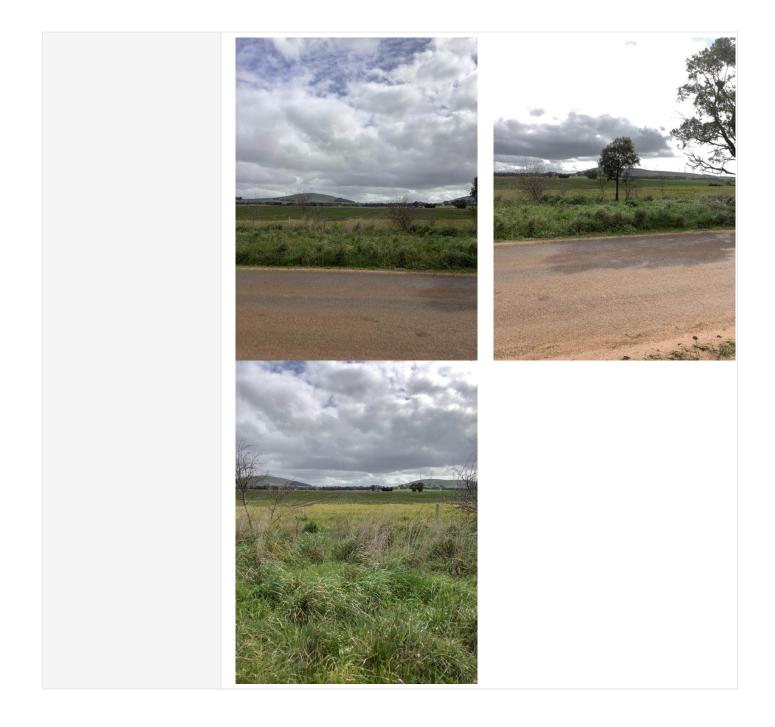
Notes on Geological Significant Features			
General Ground Conditions Comments	Newer volcanics in low lying areas surrounded by granite hills.		
Notes on Topography	Flat surrounded by hills.		
Other Observations	Farm use, landscape fairly lush with vegetation, landforms appear stable.		
Photos	<image/>

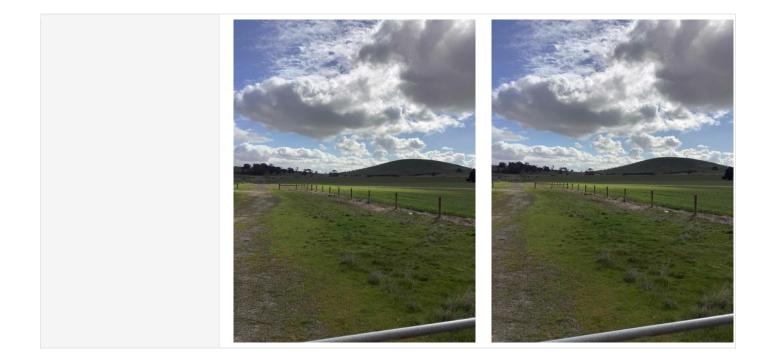
Checkpoint ID		EMO-CP08	
Precinct		Western Precinct	
Address			
Coordinates		() mepbox	Cone Hand Rd © Wabpox, © Obeu2treetWab
Are there signs of erosion or gullying or areas susceptible to erosion and gullying? (Yes/No)		No	
Are there signs of erosion management? (Yes/No)		Yes	
Are there signs of landslides or areas of landslide susceptibility visible? (Yes/No)		No	
Are there any geological significant features? (Yes/No)		Yes	
Notes on Erosion and Gullying			
Notes on Erosion Management	Erosion Management C point.	verlay (EMO) to north of aligr	nment associated with eruption
Notes on Landslide Susceptibility

Notes on Geological Significant Features	Eruption point.
General Ground Conditions Comments	Newer Volcanics basalt.
Notes on Topography	Undulating with eruption points.
Other Observations	Farmland.
Photos	<image/>

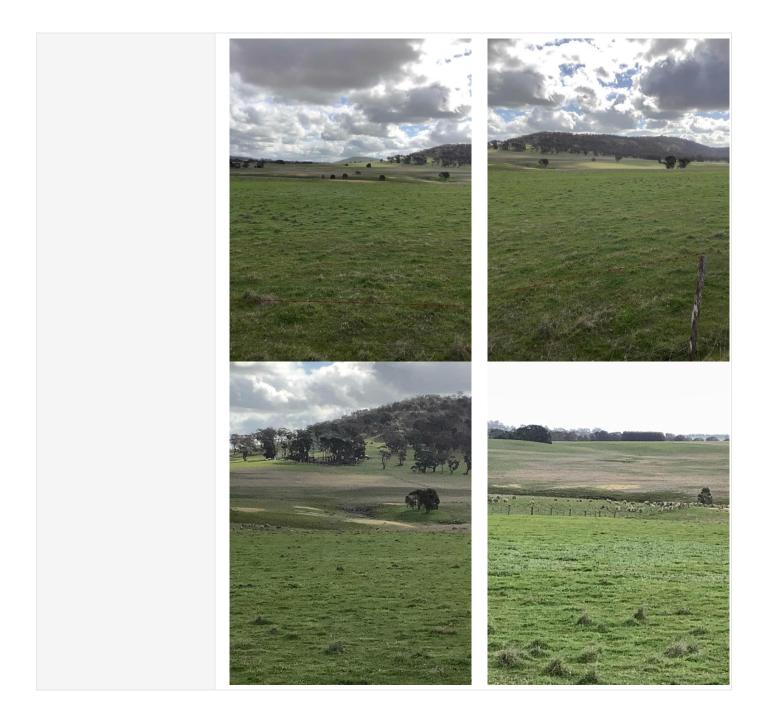
Notes on Geological Significant Features	Small eruption point to north of alignment.		
General Ground Conditions Comments	Newer Volcanics basalt, possible shallow rock, outcropping observed near creek.		
Notes on Topography	Slightly undulating.		
Other Observations	Soil sample 15b, Silty CLAY: medium to high plasticity, dark red brown (Newer Volcanics residual soil).		
Photos	<image/>

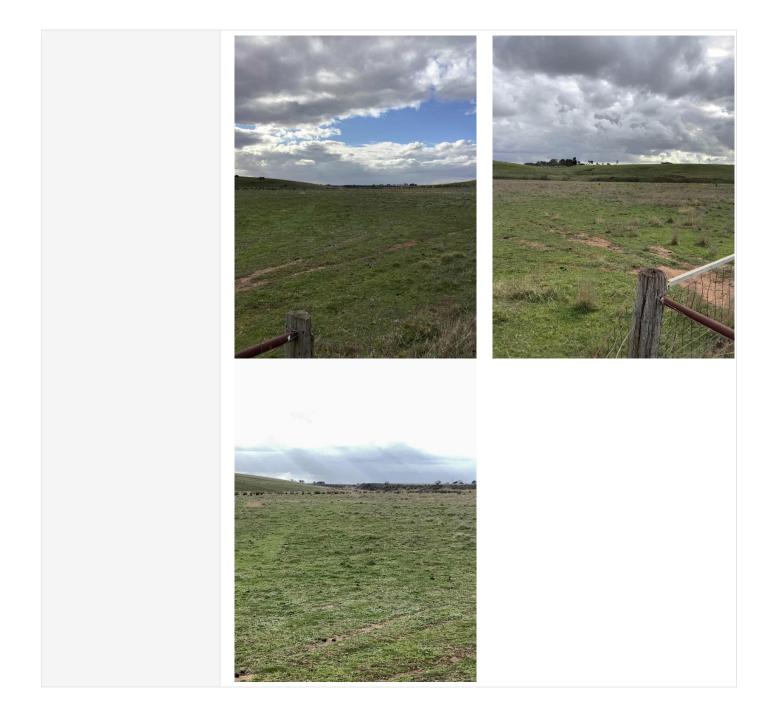
Notes on Geological Significant Features			
General Ground Conditions Comments	Newer Volcanics basalt plains with creek running through north to south forming steep valley.		
Notes on Topography	Slightly undulating with steep creek valley.		
Other Observations	Soil sample 16, Clayey Sandy SILT: medium to high plasticity, red brown (Newer Volcanics residual soil).		
Photos	<image/>
