Q Geology and Soils Impact Assessment

Western Renewables Link EES Technical Report EES Technical Report Q

IS311800-EES-CG-RPT-0001 | 1.0 17 June 2025

AusNet Transmission Group Pty Ltd

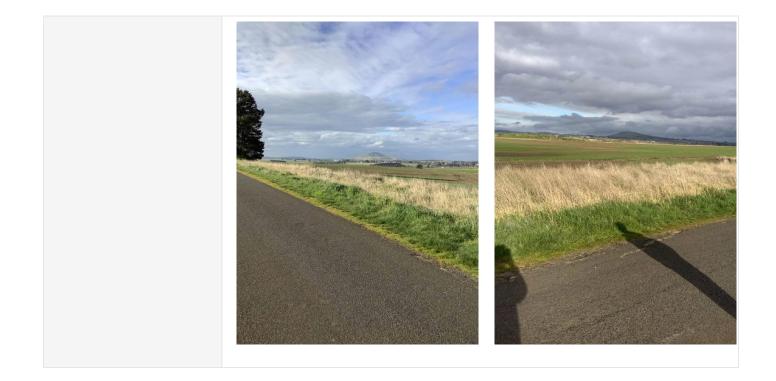
Checkpoint ID		EMO-CP09	
Precinct		Western Precinct	
Address		Werona Kingston Rd	
Coordinates		Bullarook Creek Streamside Reserve	
Are there signs of erosion or gullying or areas susceptible to erosion and gullying? (Yes/No)		Yes	
Are there signs of erosion management? (Yes/No)		No	
Are there signs of landslides or areas of landslide susceptibility visible? (Yes/No)		No	
Are there any geological significant features? (Yes/No)		No	
Notes on Erosion and Gullying	Natural erosion from fo	prmation of creek.	
Notes on Erosion Management			
Notes on Landslide Susceptibility

Notes on Geological Significant Features			
General Ground Conditions Comments	Newer Volcanics basalt with stream/creek.		
Notes on Topography	Undulating.		
Other Observations	Creek area heavily vegetated near historic bridge. Soil sample 17, Sandy SILT: medium to high plasticity, red brown (Newer Volcanics).		
Photos	<image/>

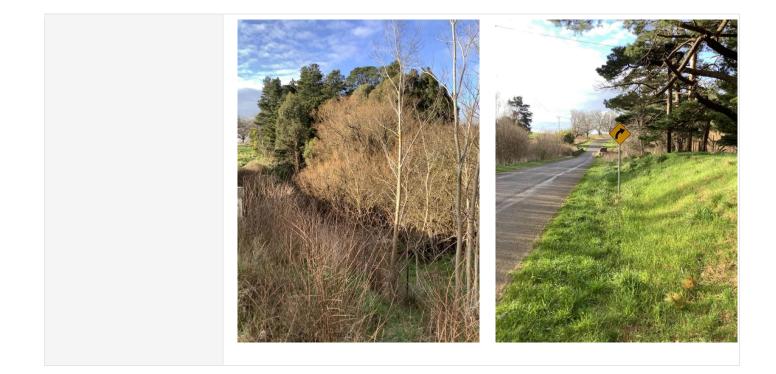
Checkpoint ID		EMO-CP10	
Precinct		Western Precinct	
Address		Telegraph road	
Coordinates		Telegraph Rd	^r elegraph Rd
Are there signs of erosion or gullying or areas susceptible to erosion and gullying? (Yes/No)		No	
Are there signs of erosion management? (Yes/No)		Yes	
Are there signs of landslides or areas of landslide susceptibility visible? (Yes/No)		No	
Are there any geological significant features? (Yes/No)		Yes	
Notes on Erosion and Gullying			
Notes on ErosionLarge erosion managemManagementalignment.		ent overlay associated with eruption point to south o	f
Notes on Landslide Susceptibility

Notes on Geological Significant Features	Large hill eruption point.	
General Ground Conditions Comments	Newer Volcanics basalt.	
Notes on Topography	Flat with hills at eruption points.	
Other Observations	Soil sample 18, Silty CLAY: medium plasticity, red brown (Newer Volcanics residual soil).	
Photos	<image/>

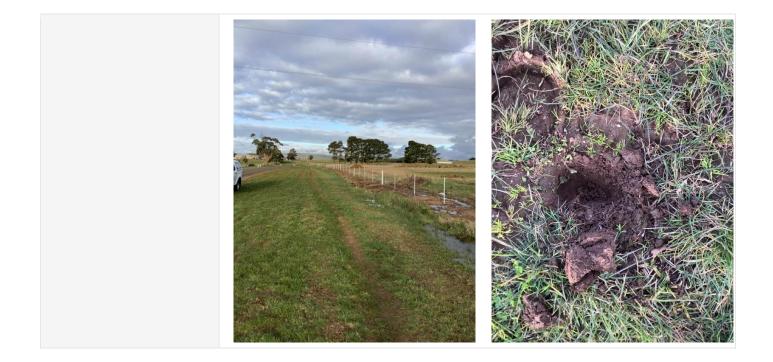
Checkpoint ID		EG-CP18
Precinct		Eastern Precinct
Address		
Coordinates		Long Pt Rd
		ে Mapbox, © OpenStreetMap
Are there signs of erosion or gullying or areas susceptible to erosion and gullying? (Yes/No)		Yes
Are there signs of erosion management? (Yes/No)		No
Are there signs of landslides or areas of landslide susceptibility visible? (Yes/No)		Yes
Are there any geological significant features? (Yes/No)		No
Notes on Erosion and Gullying	Erosion localised around	d landslips on valley sides where soil has been exposed.
Notes on Erosion Management		
Notes on Landslide SusceptibilitySteep valley sides with on the slopes above.		and slipping observed, mainly within the river valley and not

Notes on Geological Significant Features			
General Ground Conditions Comments	Pentland Hills Older Volcanics with Permian Bacchus Marsh Formation at base of valley.		
Notes on Topography	Moderately undulating to hilly topography.		
Other Observations			
Photos

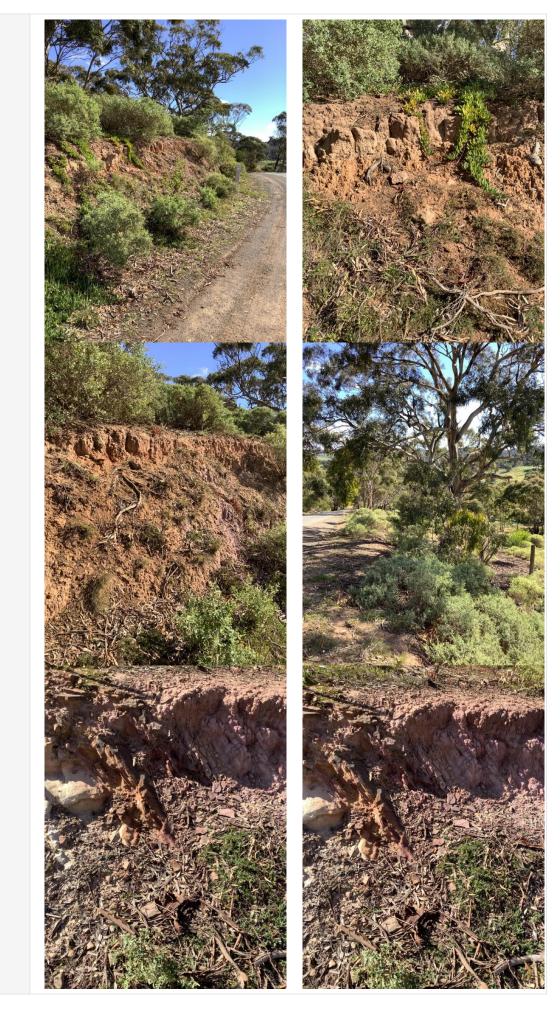
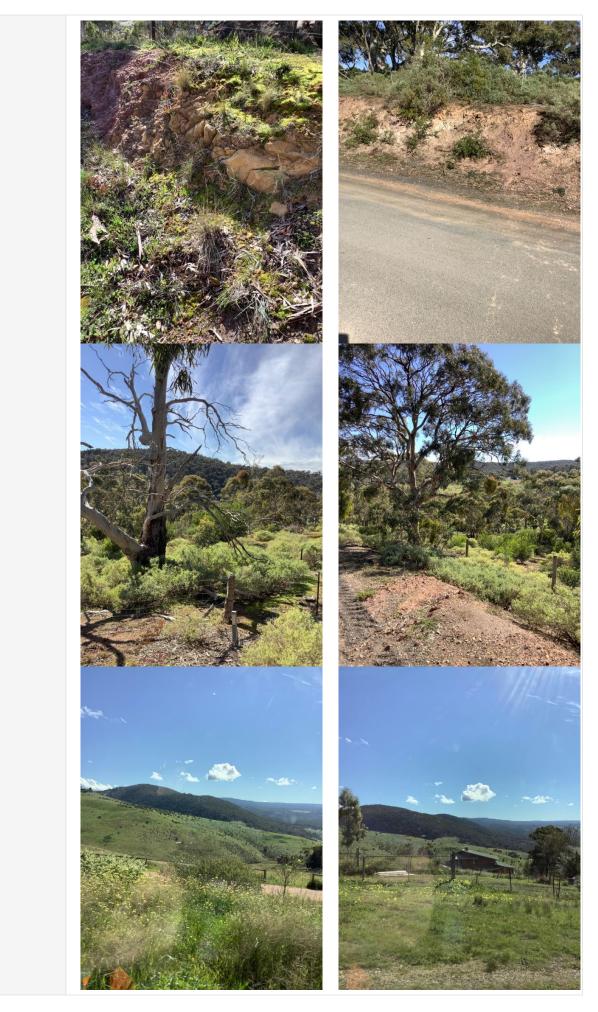
Notes on Geological Significant Features			
General Ground Conditions Comments	Bacchus Marsh Formation and Castlemaine Group sedimentary rock units, high rock head, low to high strength rock.		
Notes on Topography	Very steep valley and hills.		
Other Observations	Difficult access to locations, soil sample 19, Clayey SILT: low plasticity, orange brown, trace gravel (Bacchus Marsh Formation Permian).		
Photos	<image/>

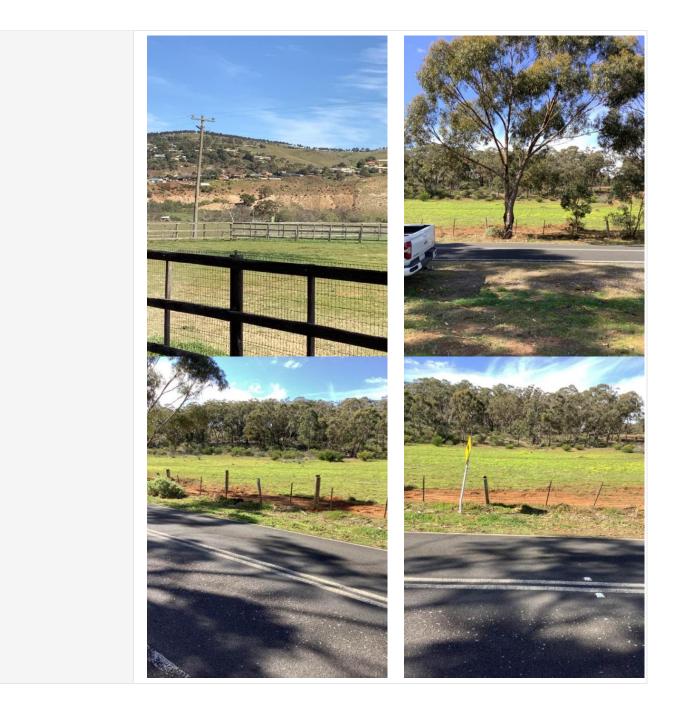
Notes on Geological Significant Features			
General Ground Conditions Comments	Transmission line coming over Permian and Castlemaine group hill onto alluvium flats associated with Lerderberg River, upper surface of alluvium comprises orange brown silty sand with gravel.		
Notes on Topography	Flat in alluvial terraces, hilly elsewhere.		
Other Observations	Soil sample 20, Silty SAND: fine to medium grained, red brown (Alluvium).		
Photos	<image/>

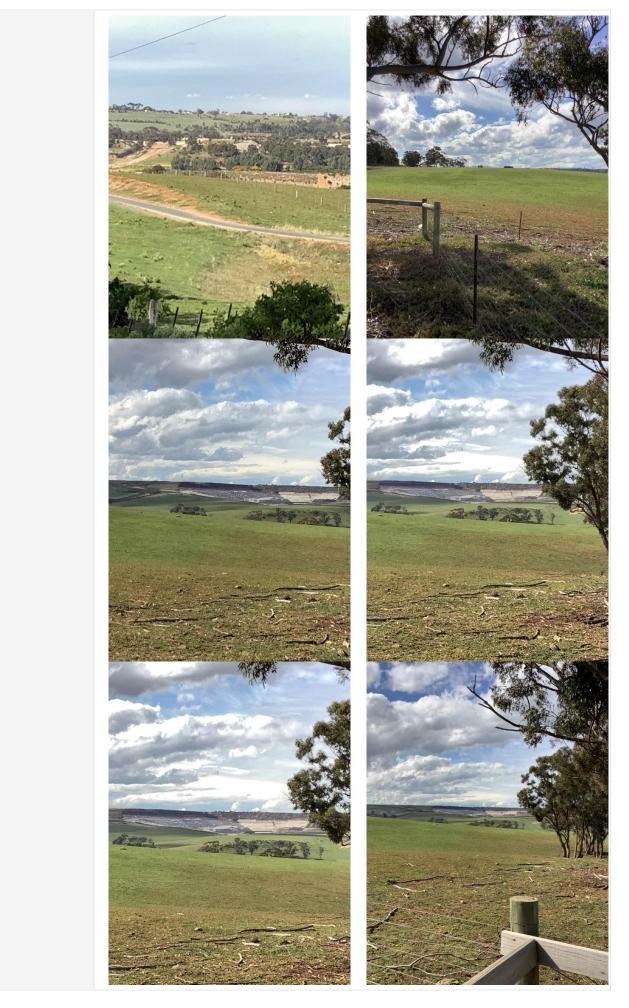
Notes on Geological Significant Features	Large quarry in Werribee Formation sands.		
General Ground Conditions Comments	Mixture of geological units, refer to web map.		
Notes on Topography	Moderately undulating.		
Other Observations	Alignment passes through large quarry, noted that one tower location currently placed in quarry waste deposits.		
Photos	<image/>

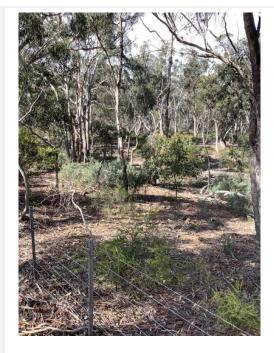
Proposed tower location near historic gully

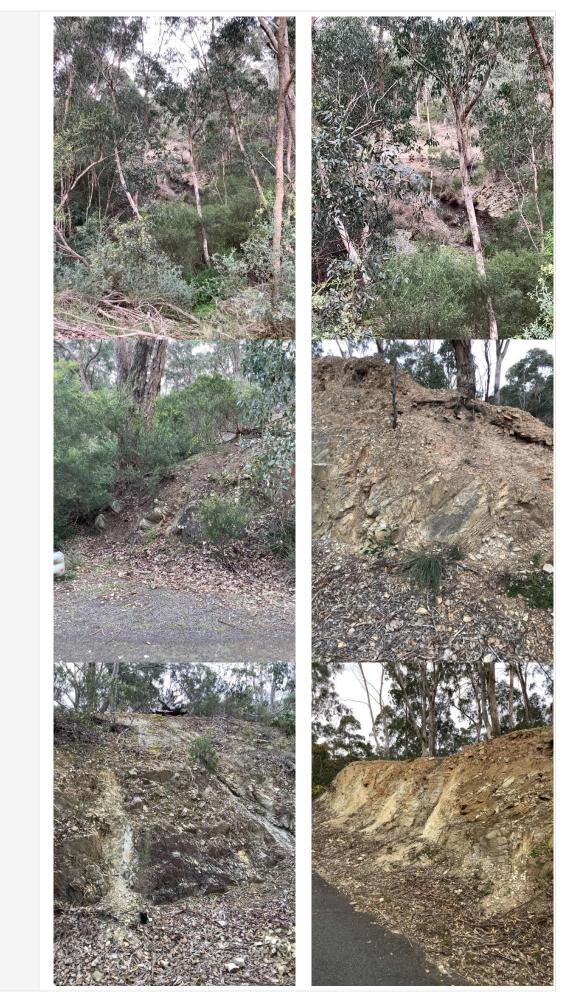
Notes on Geological Significant Features	Exposed siltstone/sandstone, cut good example of highly disturbed rock.
General Ground Conditions Comments	Creek incised into siltstone/sandstone units, Riddle Sandstone Gisbornian, road cut into sedimentary rock, cuttings bedding dipping steeply to the west, interbeds of competent bands mixed with shaly bands, both highly deformed. Failures observed in shaly bands, intact competent bands medium to high strength rock, shaly bands low to very low strength, rock level appears to be high.
Notes on Topography	Undulating steep slopes at creek.
Other Observations	Soil sample 22, Sandy SILT: low plasticity, light brown, with gravel (Riddell Sandstone Gisbornian, residual soil).
Photos	<image/>

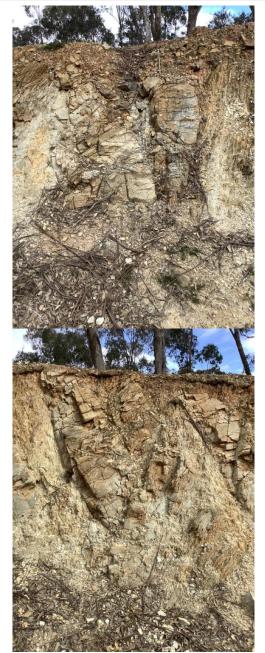
Localised failure in cut slope

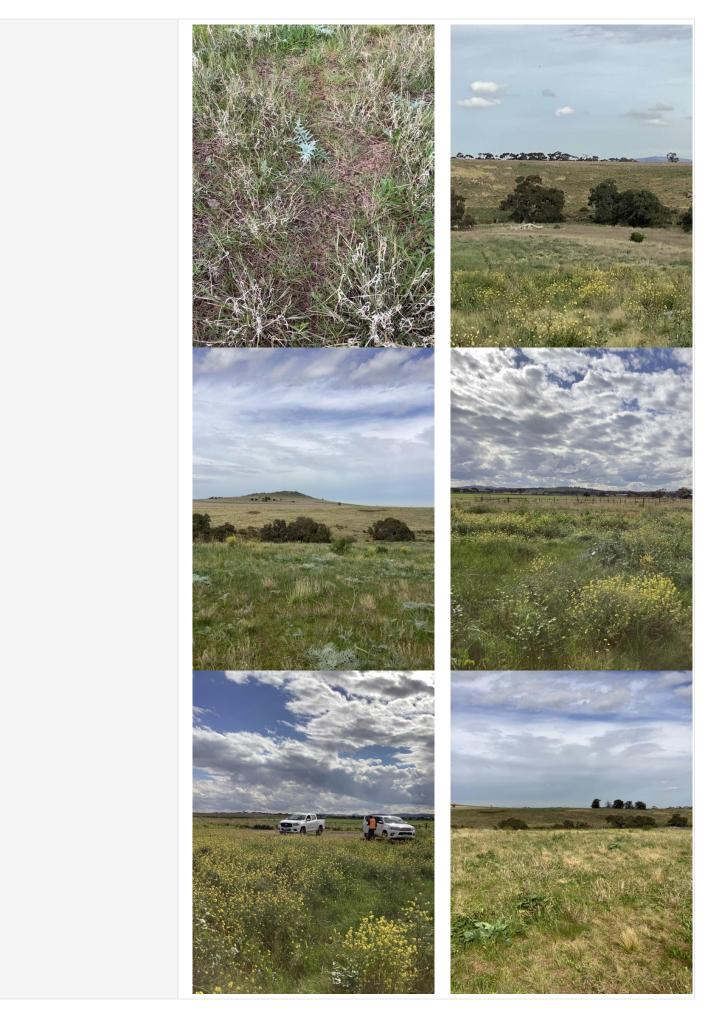
Notes on Geological Significant Features			
General Ground Conditions Comments	Newer Volcanics basalt with Kororoit Creek incised through basalt, shrink swell cracking observed in residual soil, rock exposed on steep slopes, basalt floaters and cobbles in residual soil.		
Notes on Topography	Gentle to steep slopes around creek, mostly flat basalt plains		
Other Observations	Soil sample 23, CLAY: high plasticity, brown, with gravel (Newer Volcanics Basalt Residual Soil).		
Photos	<image/>	<image/>

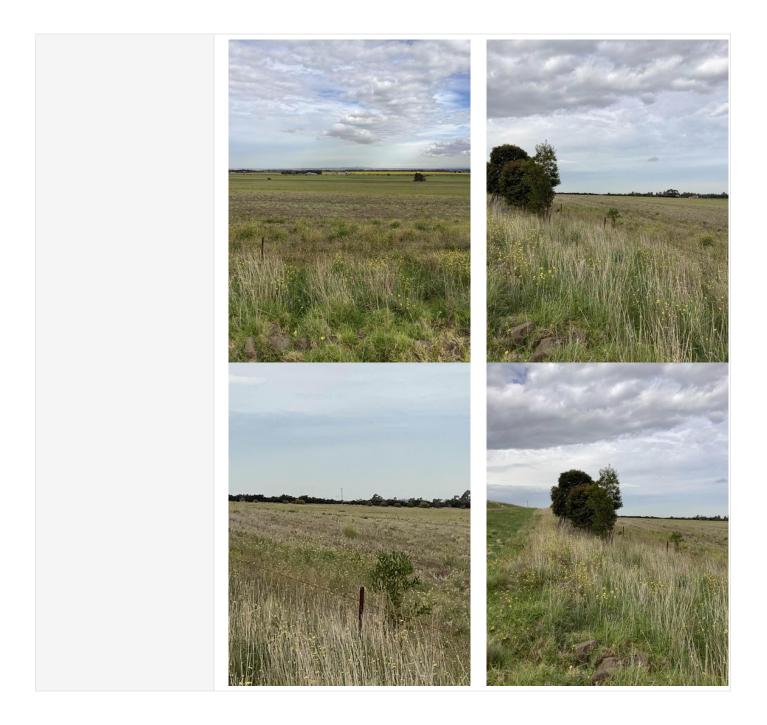
Notes on Geological Significant Features	Mt Kororoit eruption point, already has phone tower and radio tower with small power line, not publicly accessible, can be viewed from Mount Kororoit road at base of eruption point, towers positioned at base of eruption point, no decrease in accessibility to feature.	
General Ground Conditions Comments	Newer Volcanics basalt with rock outcropping at top of eruption point.	
Notes on Topography	Flat with eruption point.	
Other Observations		
Photos	<image/>
