**Western Renewables Link  
EES Technical Report R  
Contaminated Land Impact Assessment**

IS311800-EES-CL-RPT-0003 | 1.0

**AusNet Transmission Group Pty Ltd**

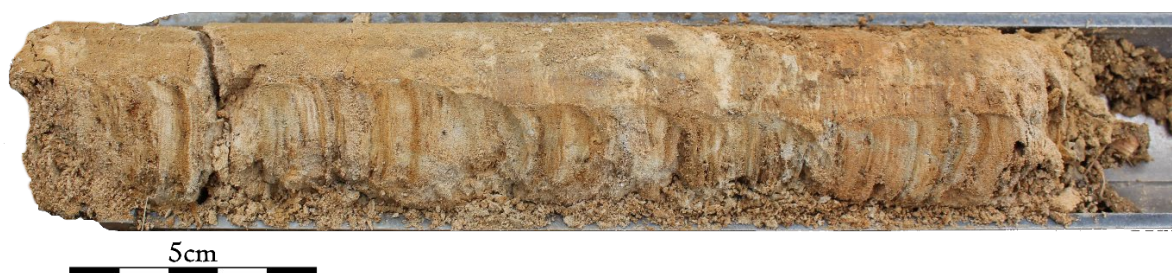
**Figure 3.** An example of sludge showing within the core of an auger. Note the horizontal laminations and the range of colours and texture.

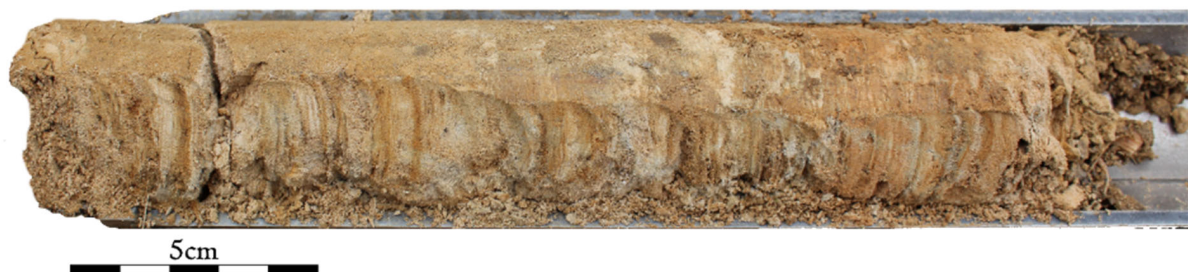
**Figure 3.** An example of sludge showing within the core of an auger. Note the horizontal laminations and the range of colours and texture.

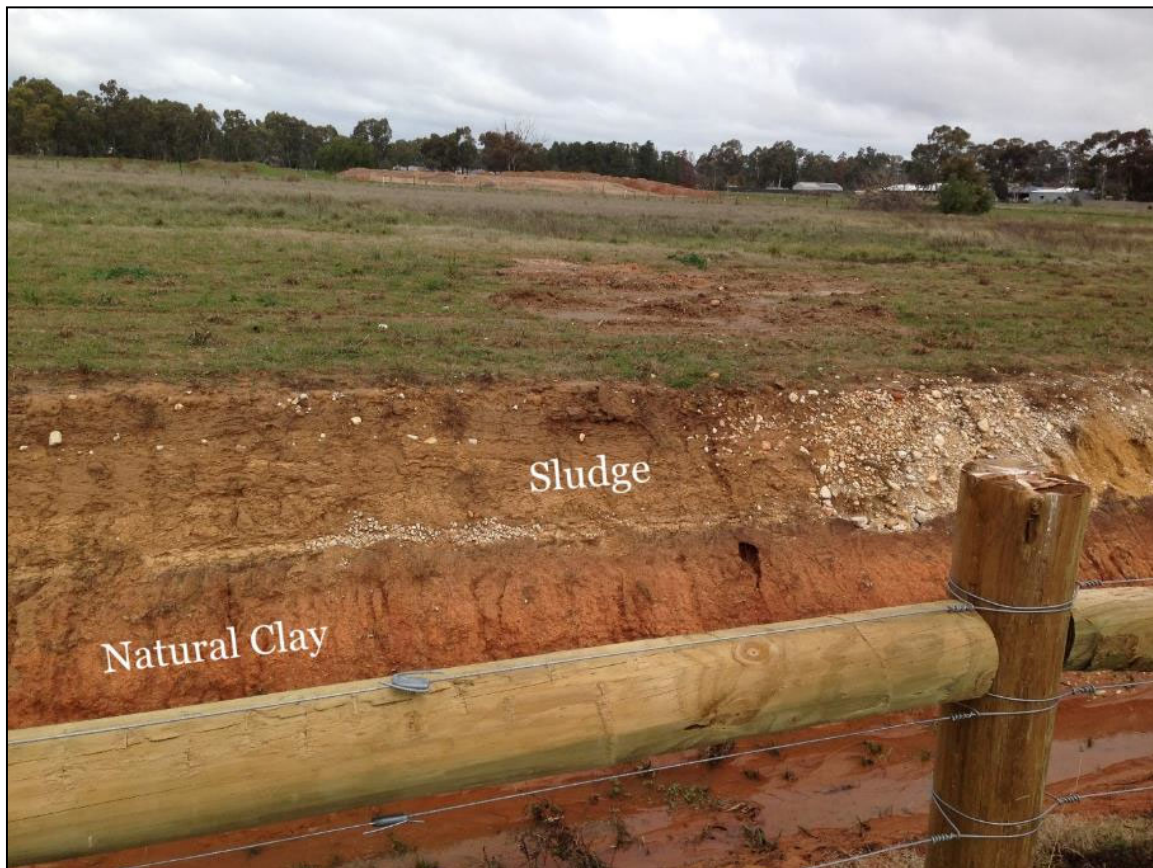
**Figure 6.** Another section of exposed sludge along the same drainage ditch as **Figure 2**. Note the variability of colour and grainsize and widely dispersed pebble lenses.

As sludge is a product of fluvial processes it sometimes contains pebbles, charcoal, European or Aboriginal cultural heritage material carried with it from upstream. In exposed sections this material can appear in long truncated lenses (**Figure 6**). The laminations present within sludge distinguish it from floodplain material, which tends to crack vertically as a result of wetting and drying expansion/contraction cycles (**Figure 4**). It should also be noted that a clear point of contact can typically be observed between sludge and pre-existing ground surfaces (**Figure 5**).

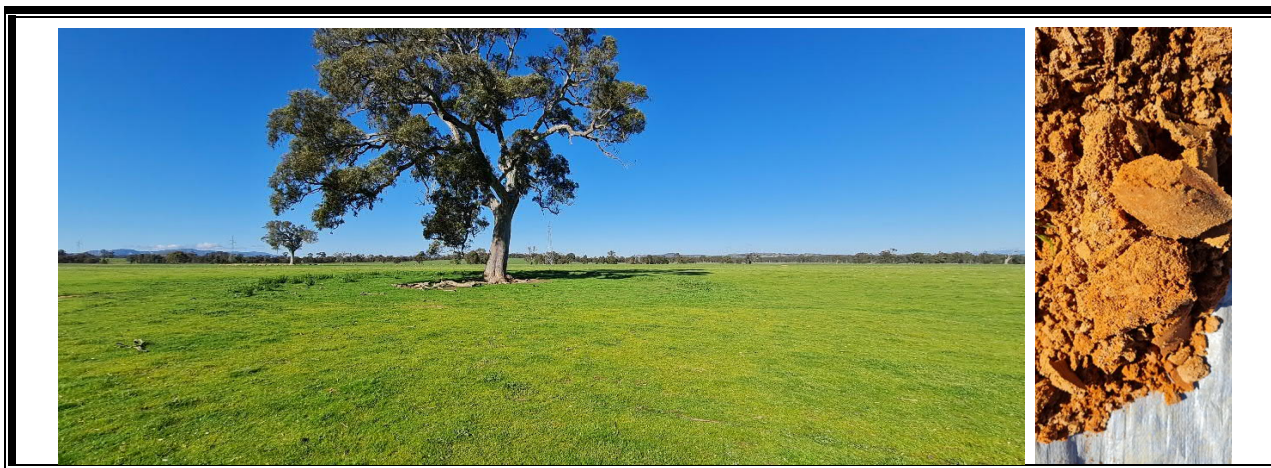
<b>Jacobs</b>	ORIENTATION South-east	PROJECT CODE IS311800	PROJECT NAME Western Victoria Transmission Network Project
	CONTENT JG/BG	DATE 19 August 2021	PLATE NUMBER Plate 1
	CHECKED JG	CLIENT AusNet Services	DESCRIPTION HA02 located at Joel Joel Road, Shays Flat. Broad acre sheep grazing paddock, existing transmission line towers visible in background of image (left) and typical silty sand with trace clay observed during hand augering (right).

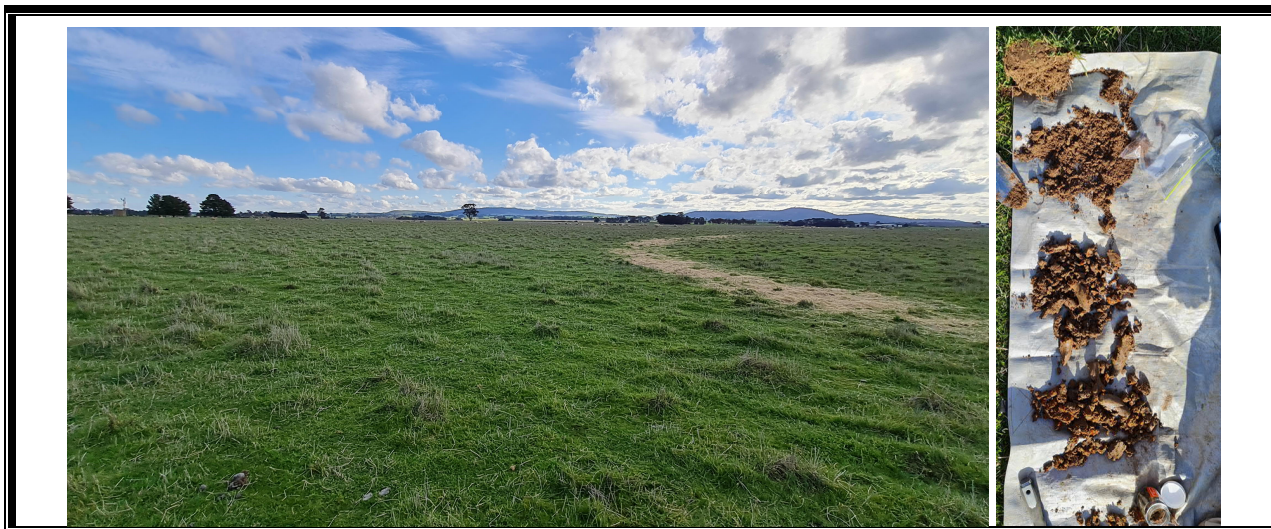
<b>Jacobs</b>	ORIENTATION North-east	PROJECT CODE IS311800	PROJECT NAME Western Victoria Transmission Network Project
	CONTENT JG/BG	DATE 19 August 2021	PLATE NUMBER Plate 3
	CHECKED JG	CLIENT AusNet Services	DESCRIPTION HA04 at Ballarat-Maryborough Road, Tourello. Broad acre sheep grazing paddock (left) and typical clay observed at different depths from surface during hand augering (right)

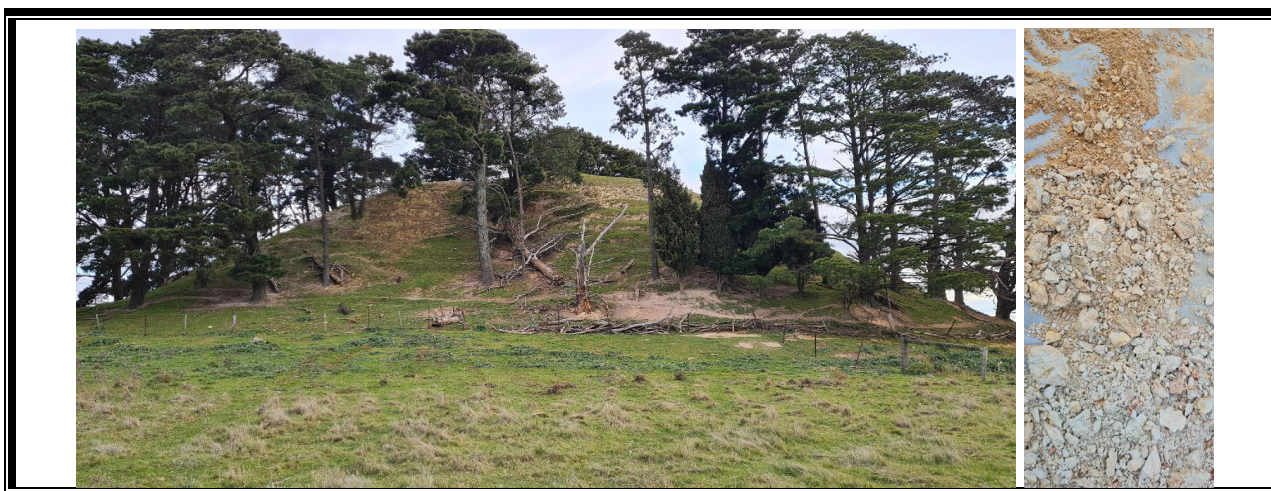
<b>Jacobs</b>	ORIENTATION South	PROJECT CODE IS311800	PROJECT NAME Western Victoria Transmission Network Project
	CONTENT JG/BG	DATE 18 August 2021	PLATE NUMBER Plate 4
	CHECKED JG	CLIENT AusNet Services	DESCRIPTION HA05 at Charlesons Road, Allendale. Mine tailings mound (background) and broad acre sheep grazing paddock (foreground) (left) and typical silt observed during hand augering (right).

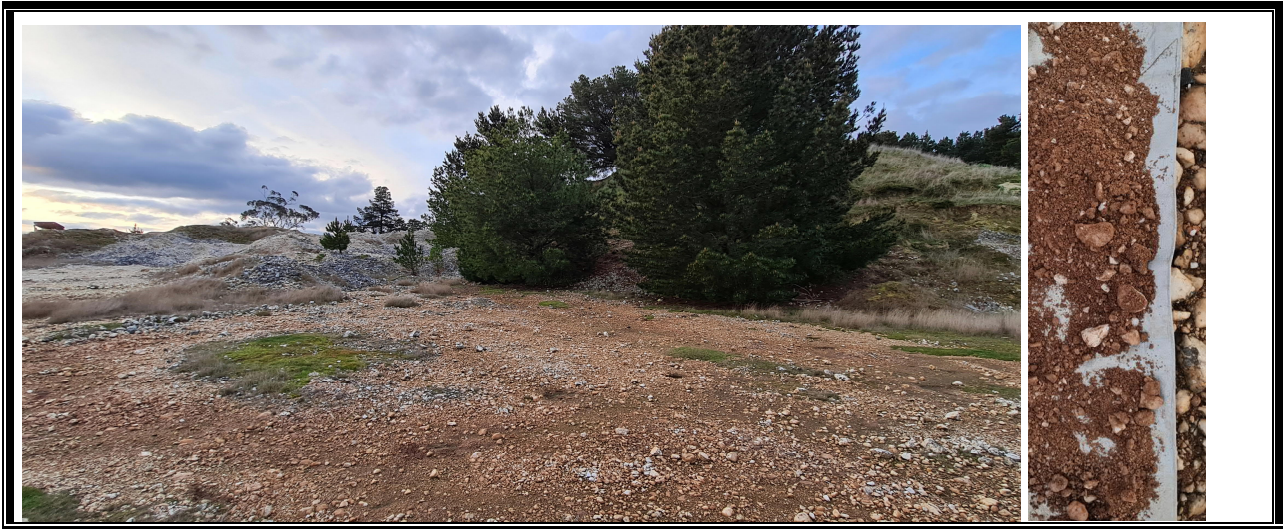
<b>Jacobs</b>	ORIENTATION North	PROJECT CODE IS311800	PROJECT NAME Western Victoria Transmission Network Project
	CONTENT JG/BG	DATE 18 August 2021	PLATE NUMBER Plate 5
	CHECKED JG	CLIENT AusNet Services	DESCRIPTION HA10 at Lone Hand Road, Allendale. Gold mining spoil mounds and quartz cobbles (left) and typical gravelly sand observed during hand augering (right).

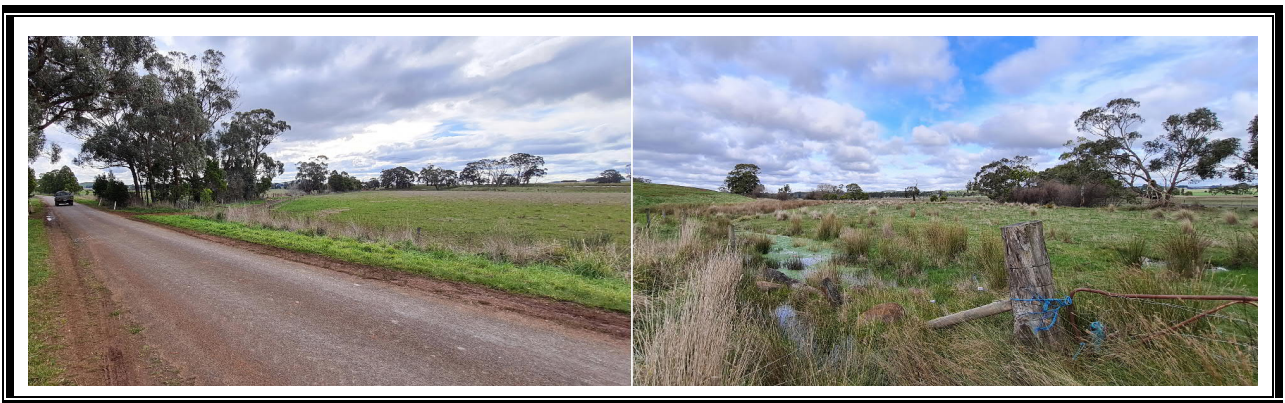
<b>Jacobs</b>	ORIENTATION West & south	PROJECT CODE IS311800	PROJECT NAME Western Victoria Transmission Network Project
	CONTENT JG/BG	DATE 18 August 2021	PLATE NUMBER Plate 6
	CHECKED JG	CLIENT AusNet Services	DESCRIPTION HA15 at Long Swamp Road, Dean. Long Swamp Road and broad acre grazing paddock (left) and nearby Pinchgut Creek (right).

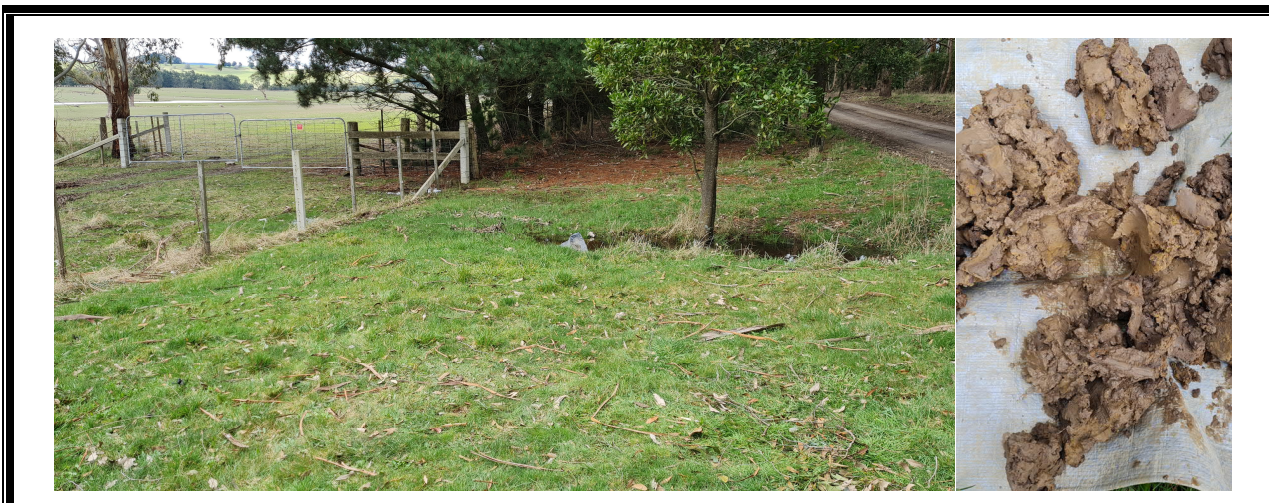
<b>Jacobs</b>	ORIENTATION North-west	PROJECT CODE IS311800	PROJECT NAME Western Victoria Transmission Network Project
	CONTENT JG/BG	DATE 18 August 2021	PLATE NUMBER Plate 7
	CHECKED JG	CLIENT AusNet Services	DESCRIPTION HA17 at Callaghans Lane, Gordon. Roadside along Callaghans Lane and broad acre grazing paddock (left). Typical clay observed during hand augering (right).

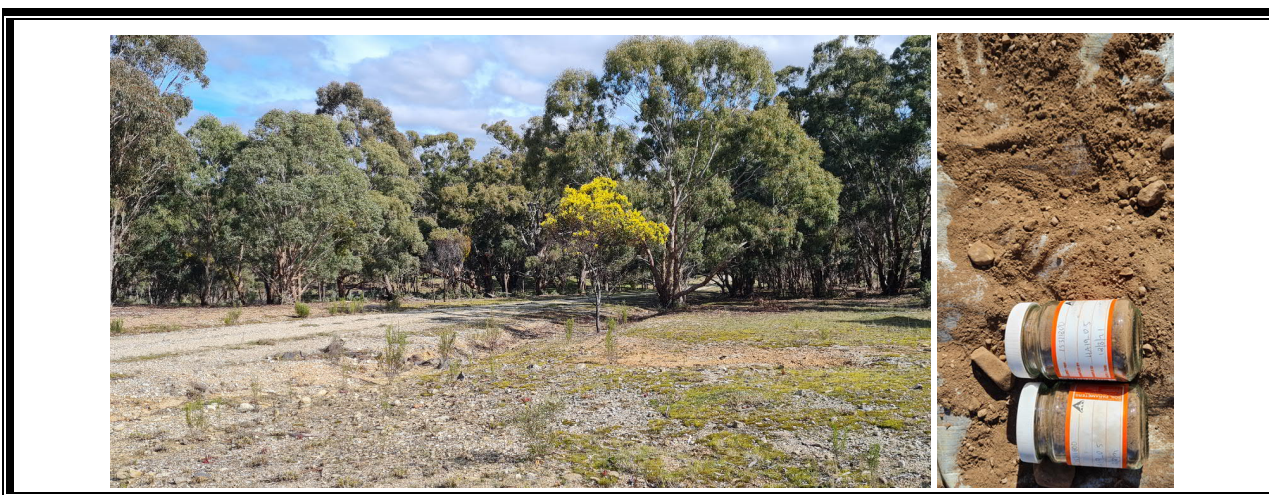
<b>Jacobs</b>	ORIENTATION South-west	PROJECT CODE IS311800	PROJECT NAME Western Victoria Transmission Network Project
	CONTENT JG/BG	DATE 18 August 2021	PLATE NUMBER Plate 8
	CHECKED JG	CLIENT AusNet Services	DESCRIPTION HA19 at Quarry Road, Coimadai. Site setting along Quarry Road, Merrimu (left) and typical silty clay observed during hand augering prior to refusal in clay and gravel (right).
